HISTORIC RESOURCES INVENTORY:
 Buildings & Structures

SURVEY OF GUILFORD, NEW HAVEN COUNTY, 06437
 June-December 1981

- ADDRESS** 102 Church Street
(map 46, lot 23)
- NAME**
(historic) George Weld
NAME
(common)
- USE**
(historic)
USE
(present) Private house
- IF MOVED, WHEN AND FROM WHERE:**

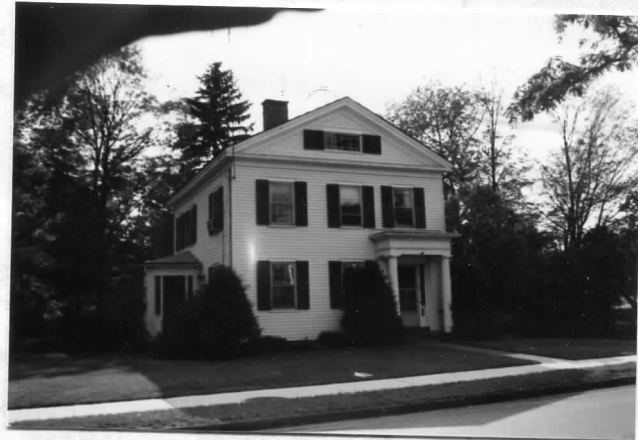
- ARCHITECT**
- DATE** c1848 **BUILDER**
STYLE Greek Revival

7. ALTERATIONS
 Siding; side screened porch; south side addition; closed sidelights.

8. NOTABLE FEATURES
 Full pedimented cornice, original rectangular gable window. Portico with entablature, dentils fluted columns, original paneled door.
