HISTORIC RESOURCES INVENTORY:
 Buildings & Structures

SURVEY OF GUILFORD, NEW HAVEN COUNTY, 06437
 June-December 1981

1. **ADDRESS** 150 Church Street
(map 46, lot 142)
2. **NAME**
(*historic*) William Starr III
NAME
(*common*)
3. **USE**
(*historic*)
USE
(*present*) Private house
4. **IF MOVED, WHEN AND FROM WHERE:**

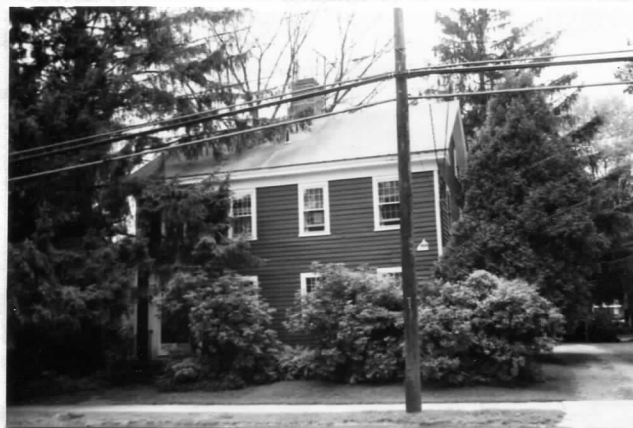
5. **ARCHITECT**
6. **DATE** 1826 **BUILDER**
STYLE Federal
7. **ALTERATIONS**
Step railing; two over two windows (side).

Boxed cornice with returns on the side; frieze; 12/12 sash; doorway with entablature and slender pilasters; brick central chimney.

This four bay house of the Federal period stands on one of the main thoroughfares leading into the center of Guilford. This house is representative of a form used in Guilford before the 1830's. This house was built for his bride by William Starr, Jr., who married on 31 January 1827, Amelia Chittenden. The Guilford-Durham Turnpike had just been built. It had cut off the west side of the Starr property on State Street, land that had been held by the Starr family since 1694.
