HISTORIC RESOURCES INVENTORY:
 Buildings & Structures

SURVEY OF GUILFORD, NEW HAVEN COUNTY, 06437
 June-December 1981

1. ADDRESS 233 Church Street
(map 53, lot 17)
2. NAME
(historic) Guilford High School
NAME
(common) Elisabeth C. Adams Middle School
3. USE
(historic) School
USE
(present) School
4. IF MOVED, WHEN AND FROM WHERE:

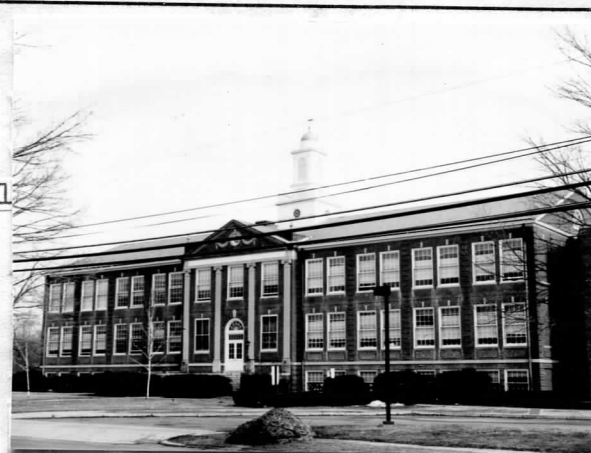
5. ARCHITECT G. Archer Quick with Schilling and Goldbecker, New Haven
6. DATE 1936
- BUILDER E & F Construction Co. of Bridgeport
- STYLE Colonial Revival
7. ALTERATIONS Large South addition (Schilling and Goldbecker, 1954) with glass front facing west; remodeled and bricked up, 1970s. Further additions to the rear at the same time.

8. NOTABLE FEATURES Impressive but gracious frontal statement on the street, using the vocabulary of the Colonial Revival (frontispiece with pilasters and swags, cupola, and a splendid battery of 12/12 windows) to scale a big building down to a town setting.
