HISTORIC RESOURCES INVENTORY - BUILDING AND STRUCTURES

Building Name (Common) 397 Church Street
 Building Name (Historic) Robert S. Maynard House
 Street Address or Location 397 Church Street
 Town/City Guilford Village _____ County New Haven
 Owner(s) Gail and Daniel Kotowski Public Private

397 Church Street

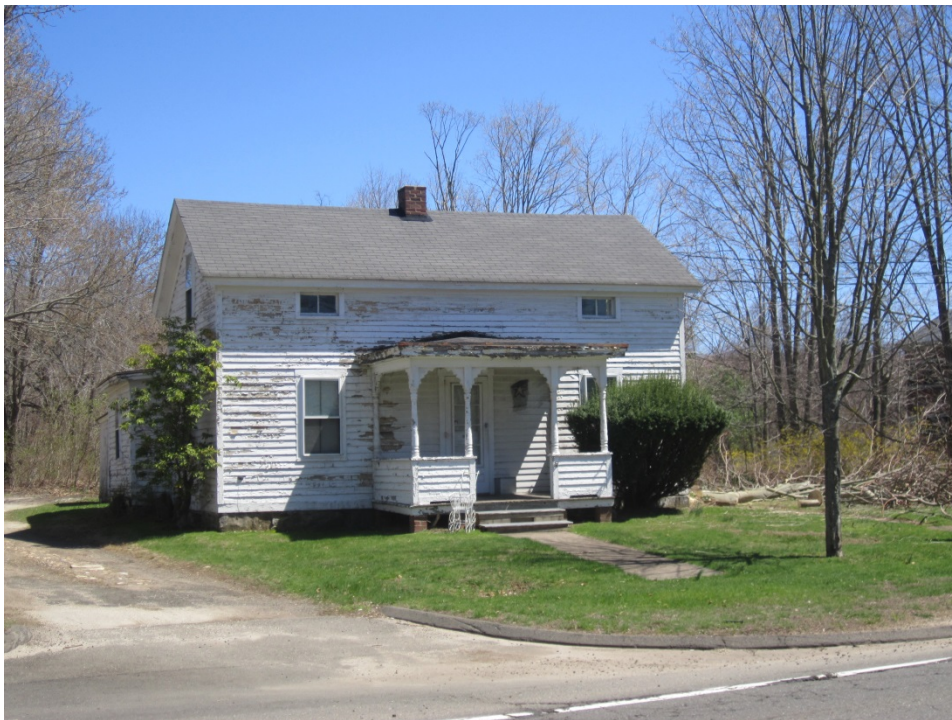
This is a Colonial Revival style, one and a half-story dwelling with an attic and a side-gable roof. The house is sheathed in clapboard siding, the roof is covered with asphalt shingles, and the foundation is stone. The three-bay façade faces west. The main entry is centered on this side and is reached by stone steps. A partial-width, open front porch is centered on the facade. (See continuation sheet)

Photographer Kristen Nietering Date 4/26/2015
View West view of the house, camera facing east. Negative on File _____
Name Kristen Nietering Date 10/10/2015
Organization Guilford Preservation Alliance
Address 199 PO Box Guilford, CT 06437

It has a hipped-roof and slender, decorative posts. Fenestration consists of two-over-two double-hung sash windows and two-pane rectangular windows. A brick chimney is centered atop the ridgeline of the roof. Additions are located on the east elevation of the house.
