HISTORIC RESOURCES INVENTORY:
 Buildings & Structures

SURVEY OF GUILFORD, NEW HAVEN COUNTY, 06437
 June-December 1981

1. **ADDRESS** 49 Church Street
 (map 39, lot 42)
2. **NAME**
(historic) Fred Fowler
NAME
(common)
3. **USE**
(historic)
USE
(present) Private house
4. **IF MOVED, WHEN AND FROM WHERE:**

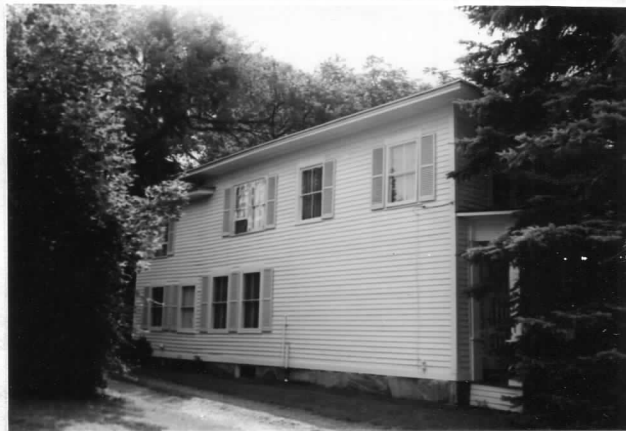
5. **ARCHITECT**
6. **DATE** c1848 **BUILDER**
STYLE Italian Villa
7. **ALTERATIONS**
 Side screened porch; 2/2 sash.

Wide eaves; frieze; square columns on large square bases support the porch; sidelights flank the door; large granite block foundation.

This small Italian villa on Church Street is smaller in scale than some of the others in the village. It is similar to, but less elaborate than, the two villas at #11 and #15 Fair Street. The Church Street house has a portico with square columns on square bases.
