HISTORIC RESOURCES INVENTORY:
Buildings & Structures

SURVEY OF GUILFORD, NEW HAVEN COUNTY, 06437

1. ADDRESS 174 Clapboard Hill Road
(map 75, lot 15)
2. NAME John Griswold II
(historic)
NAME
(common)
3. USE
(historic)
USE
(present) Private house
4. IF MOVED, WHEN AND FROM WHERE:

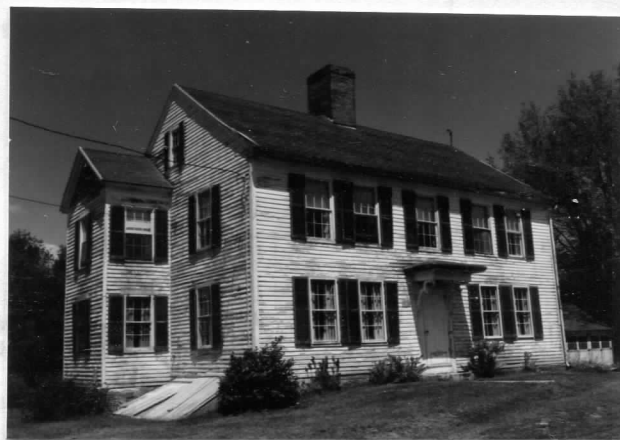
5. ARCHITECT
6. DATE 1806-7
- BUILDER
STYLE Federal
7. ALTERATIONS
The side addition appears to be only a little later than the house itself. Chimney may be rebuilt but in original form and location. The sprightly door hood was probably added soon after the Civil War.
8. NOTABLE FEATURES
Overhanging eaves with a row of diamond shapes below; transom; large stone foundation.

row of diamond shapes below the eaves but otherwise has little ornament. The doorhood is a late 19th century addition.
