**HISTORIC RESOURCES INVENTORY:**  
 Buildings & Structures

**SURVEY OF GUILFORD, NEW HAVEN COUNTY, 06437**  
 June-December 1981

1. ADDRESS 726 Clapboard Hill  
(map 81, lot 30)
2. NAME Samuel Dudley (I)  
(historic)  
NAME "Old Scrogie",  
(common) (a Scot's word for barren land)
3. USE Private house  
(historic)  
USE Private house  
(present)
4. IF MOVED, WHEN AND FROM WHERE:

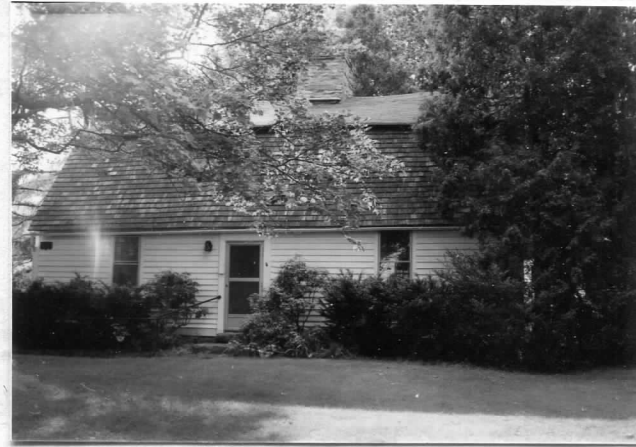
5. ARCHITECT
6. DATE 1738
- BUILDER Samuel Dudley  
STYLE Colonial
7. ALTERATIONS  
Believed to have had a pitched roof, gambrel roof added in mid or late 18th century. Rooms added at rear.
8. NOTABLE FEATURES  
12/12 sash, 6/6 sash under gambrel; very plain boards around windows and door.

9. ARCHITECTURAL-HISTORICAL  
One of the older houses in the Clapboard Hill area, the house called "Old Scrogie" has changed somewhat from the time when it was first built. The gambrel roof reportedly replaces an earlier pitched roof. While there are a number of other gambrel roofs in Guilford, its use was not widespread. It is not known whether this is the original door treatment, the screen door is modern. The setting of this house is very important. The barns and the stone walls contribute much to the property.
