HISTORIC RESOURCES INVENTORY:
 Buildings & Structures

SURVEY OF GUILFORD, NEW HAVEN COUNTY, 06437
 June-December 1981

1. **ADDRESS** 480 Colonial Road
(map 4, lot 27)
2. **NAME**
(historic) Frederick R. Griffing
NAME
(common)
3. **USE**
(historic)
USE
(present) Private house
4. **IF MOVED, WHEN AND FROM WHERE:**

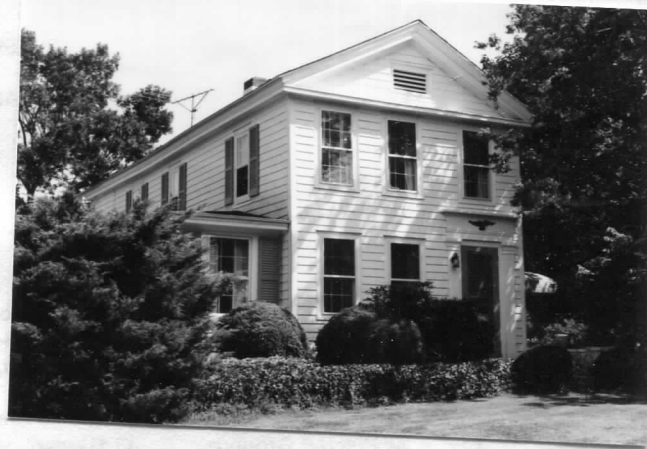
5. **ARCHITECT**
6. **DATE** c1835 **BUILDER STYLE** Greek Revival
7. **ALTERATIONS**
Shingle siding; rear addition; large picture window on the south side; vent in gable window.

8. **NOTABLE FEATURES**
Boxed pedimented cornice; 6/6 sash; rectangular gable opening; moulding around the window frames; doorway with pilasters and entablature.
9. **ARCHITECTURAL-HISTORICAL**
One of Guilford's many Greek Revival houses, although only three or four were built along with this one in the Sachem's Head area. This house seems narrower than most of Guilford's Greek Revivals. The doorway entablature and pilasters are in low relief.
