HISTORIC RESOURCES INVENTORY:
 Buildings & Structures

SURVEY OF GUILFORD, NEW HAVEN COUNTY, 06437
 June-December 1981

1. **ADDRESS** 32 Conway ^{Drive} Road
 (map 39, lot 62A)

2. **NAME** First Congregational Church
(historic) Parsonage
NAME
(common)

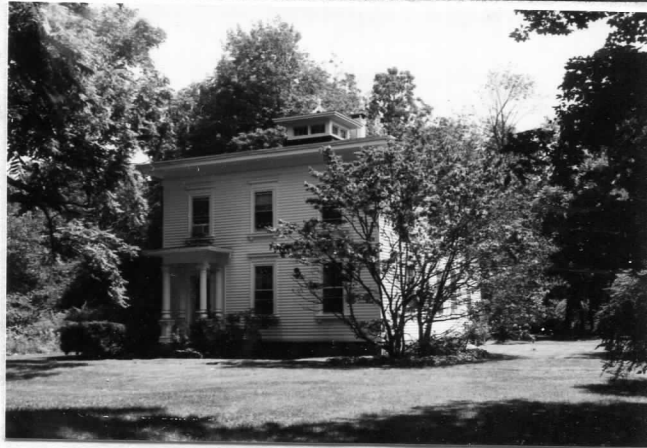
7. **ALTERATIONS**
 Concrete foundation; bubble skylight on the first story portion.

8. **NOTABLE FEATURES**
 Wide overhanging eaves; wide frieze; cupola with a finial; 6/6 sash; portico with fluted columns with stylized capitals and bases.
