HISTORIC RESOURCES INVENTORY:
 Buildings & Structures

SURVEY OF GUILFORD, NEW HAVEN COUNTY, 06437
 June-December 1981

1. **ADDRESS** 594 County Road
(map 105, lot 15)
2. **NAME**
(historic)
NAME
(common)
3. **USE**
(historic)
USE
(present) Private house
4. **IF MOVED, WHEN AND FROM WHERE:**

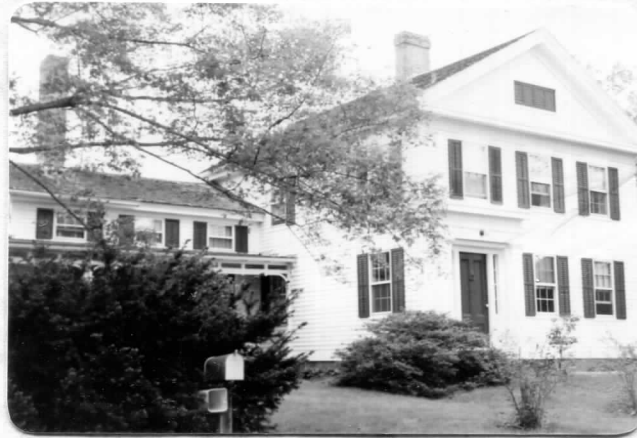
5. **ARCHITECT**
6. **DATE** c1845 **BUILDER**
STYLE Greek Revival
7. **ALTERATIONS**
Side addition with porch (later 19th century) with decorative posts and trim.

8. **NOTABLE FEATURES**
Pedimented cornice; wide frieze; 6/6 sash with a wide lintel; a slightly recessed doorway with recessed panel pilasters; large entablature and sidelights; stone block foundation.
9. **ARCHITECTURAL-HISTORICAL**
This is one of Guilford's fine Greek Revival houses. This one has a full pediment and a fine doorway. The doorway framing has more detail than is usually found on houses of this type in Guilford. The entablature is particularly tall and broad.
