**HISTORIC RESOURCES INVENTORY:**  
 Buildings & Structures

**SURVEY OF GUILFORD, NEW HAVEN COUNTY, 06437**  
 June-December 1981

- 1. ADDRESS 25 Driveway Road  
(map 33, lot 19)
- 2. NAME Edward E. Hall  
*(historic)*  
NAME  
*(common)*
- 3. USE  
*(historic)*  
USE  
*(present)* Private house
- 4. IF MOVED, WHEN AND FROM WHERE:

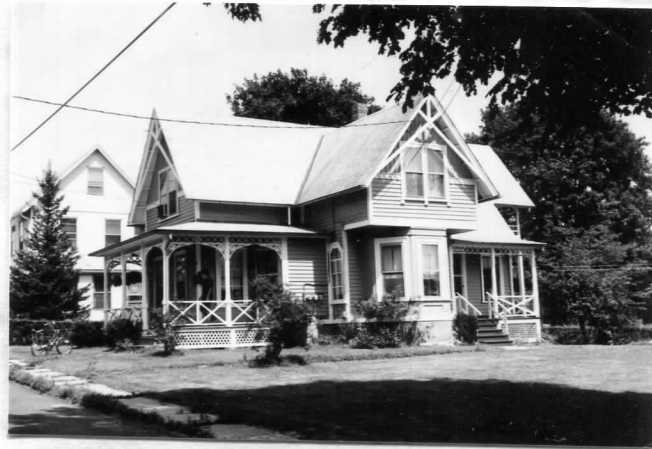
Negative ROLL 19:14

- 8. NOTABLE FEATURES  
 Ornate gable trim, suspended brace and pendant, board and batten siding, porches with scroll work and railings, side gables beveled on first floor to make a bay window.
- 9. ARCHITECTURAL-HISTORICAL  
 This small-scale stick style house is the only example of this style in the village of Guilford. With the possible exception of two houses in North Guilford, with some stick style trim, this house represents a form which was not widely used in Guilford. If there were others they have not survived. The house and its trim have been well maintained. Located on a cul-de-sac near the railroad tracks, many people may be unaware of this house.
