HISTORIC RESOURCES INVENTORY:
Buildings & Structures

SURVEY OF GUILFORD, NEW HAVEN COUNTY, 06437

1. ADDRESS 90 Duck Holes Road
(map 81, lot 28)
2. NAME
(historic) Ebenezer Scranton
NAME
(common) Duck Holes Road Farm
3. USE
(historic) Farm House
USE
(present) Private house
4. IF MOVED, WHEN AND FROM WHERE:
House moved in 1929 from Hoop Pole Road
by George Goss

1. ADDRESS 90 Duck Holes Road
(map 81, lot 28)
2. NAME
(historic) Walter Beckwith
NAME
(common)
3. USE
(historic)
USE
(present) Private house
4. IF MOVED, WHEN AND FROM WHERE:

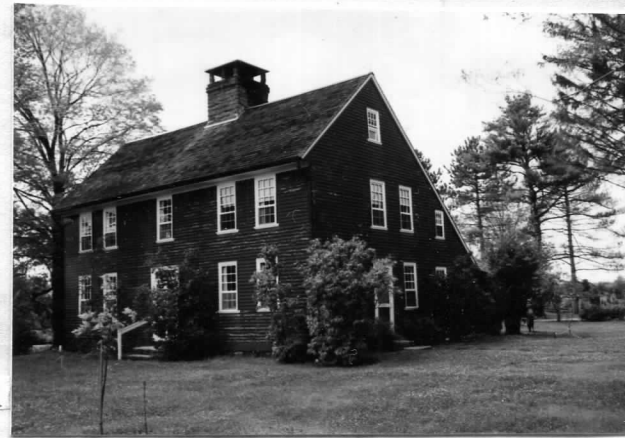
5. ARCHITECT
 6. DATE 1723
 7. ALTERATIONS
 8. NOTABLE FEATURES
- All new clapboards; (since photograph was taken); Gambrel roof ell; attached garage (rear); window sash.
- Over hanging eaves; 6/6 sash in the gable and in the second story lean-to portion; mouldings for sills; large stone chimney; double front door with a five pane transom above; "coffin door".

9. ARCHITECTURAL-HISTORICAL This large colonial house originally stood at the south end of Lake Quonnipaug in North Guilford. It is a very large five bay house similar to a number of others built in Guilford in the early part of the eighteenth century. It has been well sited in its second location beyond a saltmarsh and near a remarkable stone field. The area called Duck Holes Farm was once a feeding area for wild ducks.
- The house was originally built by Ebenezer Scranton, son of John Scranton of East Guilford. John Scranton's father, John, had come to Guilford with the original Whitfield group in 1639. The house was moved and rebuilt by Mr. & Mrs. George A. Goss, of Waterbury Conn. in 1929 and 1930

☒ Good

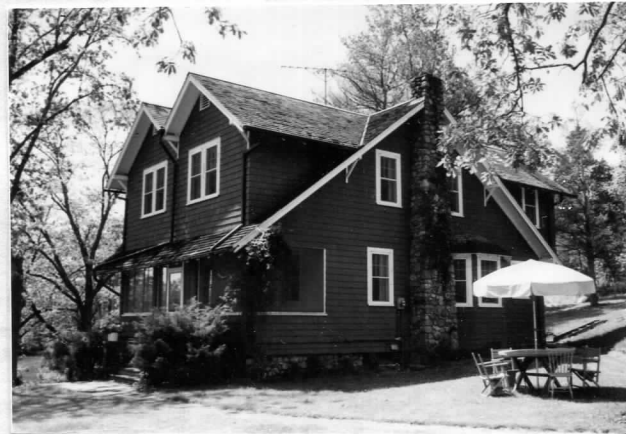
5. ARCHITECT
6. DATE 1912
7. ALTERATIONS
Screened front porch.
8. NOTABLE FEATURES
Overhanging eaves and rafters; brackets below the eaves; 6/1 sash;
one story bay window on the side; outside stone chimney; round field
stone foundation.

9. ARCHITECTURAL-HISTORICAL
This house is a version of the bungalow style seen in limited
number in Guilford. The very large pair of dormers distinguishes
it from its contemporaries. The house is located in a secluded
area and may have been used primarily as a cottage when it was built.
It appears to have been winterized. This house is part of a larger
farm complex.

☒ Fair needs paint badly
