HISTORIC RESOURCES INVENTORY:
Buildings & Structures

SURVEY OF GUILFORD, NEW HAVEN COUNTY, 06437
June-December 1981

1. ADDRESS 161 Dunk Rock Road
(map 45, lot 1)
2. NAME
(historic) Hotchkiss and Griswold
NAME
(common)
3. USE
(historic)
USE
(present) Private house
4. IF MOVED, WHEN AND FROM WHERE:

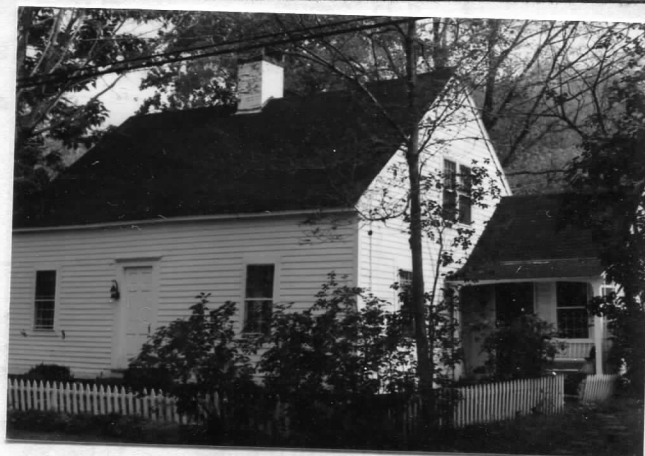
GLFD's NEG 8:17A

5. ARCHITECT
6. DATE 1861 BUILDER
STYLE Colonial
7. ALTERATIONS
Two side additions; side fenestration altered.

8. NOTABLE FEATURES
Overhanging eaves with a moulding below; 12/12 sash; plain window and door frames; moulding over the door frame; brick and stone foundation.
9. ARCHITECTURAL-HISTORICAL
This story-and-a-half Colonial house has been difficult to trace. Guilford land records list a dwelling belonging to Mark Hotchkiss on the land in 1776. The pitch of the roof and the fenestration suggest a house of that age. Land records, however, indicate a slight change in the relationship between house and road. The house is one of two early Hotchkiss houses (the other at 106 Dunk Rock Road) which have occasionally been confused. The 1852 Map lists this property with the name George Hotchkiss.

15. CONDITION: Exterior

| <input type="checkbox"/> Excellent | <input checked="" type="checkbox"/> Good | <input type="checkbox"/> Fair | <input type="checkbox"/> Poor | <input type="checkbox"/> Bad |
