HISTORIC RESOURCES INVENTORY:
 Buildings & Structures

SURVEY OF GUILFORD, NEW HAVEN COUNTY, 06437
 June-December 1981

1. **ADDRESS** 2208 Durham Road
(map 101, lot 10)
2. **NAME**
(historic) Erastus Franklin Dudley
NAME
(common)
3. **USE**
(historic)
USE
(present) Private house
4. **IF MOVED, WHEN AND FROM WHERE:**

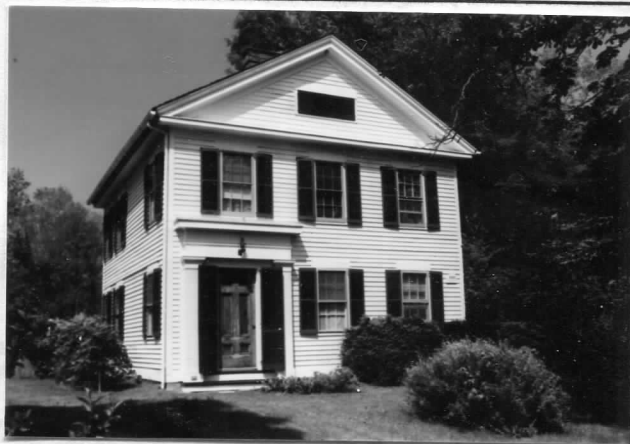
5. **ARCHITECT**
6. **DATE** 1840 **BUILDER**
STYLE Greek Revival
7. **ALTERATIONS**
Rear addition
8. **NOTABLE FEATURES**

9. **ARCHITECTURAL-HISTORICAL**
 An excellently robust and handsome example of Guilford's Greek Revival, dominated by a splendid oversized Doric doorway and a recessed door. Cornices of door and roof project vigorously, making a strong pattern of shadows on the white walls, enhanced by dark shutters. The house is well sited on a rise above the road, surrounded by mature landscaping and a fine picket fence and gate.
 Of Erastus Dudley we know only that he received permission to dam the West River near the location of his present house in order to operate machinery--evidently for some sort of pioneering manufacturing enterprise. What he planned to manufacture and whether he succeeded, the records do not tell us.
