HISTORIC RESOURCES INVENTORY:
 Buildings & Structures

SURVEY OF GUILFORD, NEW HAVEN COUNTY, 06437
 June-December 1981

- 1. ADDRESS 2209 Durham Road
(map 105, lot 31)
- 2. NAME
(historic)
NAME
(common)
- 3. USE Private house
(historic)
USE Beauty parlor and
(present) apartment
- 4. IF MOVED, WHEN AND FROM WHERE:

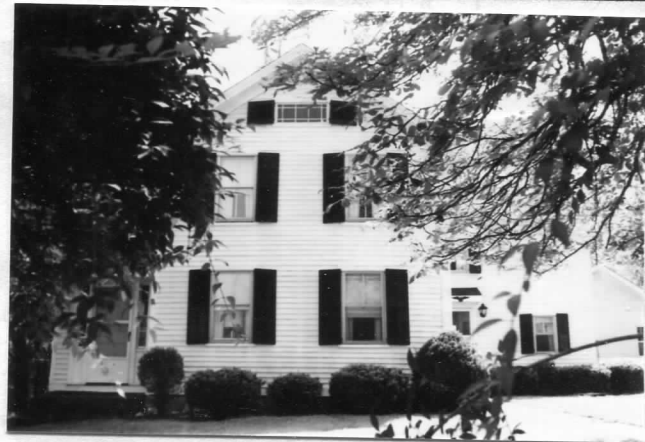
- 5. ARCHITECT
- 6. DATE c1870 BUILDER STYLE Greek Revival
- 7. ALTERATIONS
Additions on rear and on north side. Door hoods modern. Aluminum/vinyl siding. Location of door may have been changed.

- 8. NOTABLE FEATURES
Boxed cornice; small frieze; original gable window; sidelights flank the front door
- 9. ARCHITECTURAL-HISTORICAL
So many things have happened to this house, and so little original trim is now left, that it is hard to date it or assign it a style. Only the little rectangular window in the gable, with its rectilinear muntins, gives it away.
