**HISTORIC RESOURCES INVENTORY:**  
Buildings & Structures

**SURVEY OF GUILFORD, NEW HAVEN COUNTY, 06437**  
June-December 1981

1. ADDRESS 2871 Durham Road  
(map 109, lot 36)
2. NAME  
(historic)  
NAME  
(common)
3. USE  
(historic)  
USE  
(present) Private house
4. IF MOVED, WHEN AND FROM WHERE:

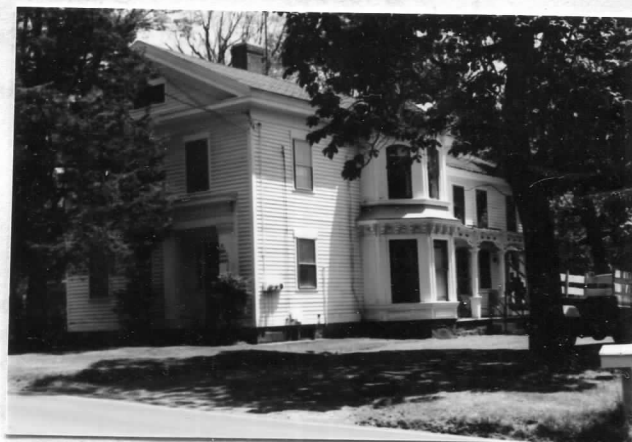
5. ARCHITECT
6. DATE c1840
- BUILDER STYLE See below
7. ALTERATIONS To a prim and proper Greek Revival house has been added a racy projecting bay some 25 years its junior. The original house, which probably dates from the 1840s, is a classic example of its style, characterized by a nice Doric entryway, a cornice drawn across the facade to suggest a pediment, and a little rectangular window in the gable--all the lines are firm and geometrically clear.

8. NOTABLE FEATURES The later bay, in its own way, is also a classic example of its style: a double-decker octagon with a small sloped roof at each level like a mini-mansard, the whole ensemble an emanation of the lush French Second Empire style of the 1860s. Bays like this were an immensely popular feature of post-Civil War American provincial architecture--a showy novelty for a new house, a simple way of modernizing an old one--Guilford has many examples. But none like this! With its rufflings of plump, curvy brackets at each roof line and with rich moldings and jigsaw applique on all possible surfaces--scrolls, rosettes, foliage--this was surely the most resplendent in town. To top it all, a crown of dainty finials shoots out of the roof, each one slim as a wand and topped by a little ball, like a birthday cake. These two unlikely partners have made a good marriage, and today both are well preserved in all details--on of the architectural treats of North Guilford. Fine barns remain out back.
