HISTORIC RESOURCES INVENTORY:
 Buildings & Structures

SURVEY OF GUILFORD, NEW HAVEN COUNTY, 06437
 June-December 1981

1. **ADDRESS** 341 Durham Road
(map 80, lot 15)
2. **NAME** Isidoro and Caroline Testori
(historic)
NAME
(common)
3. **USE**
(historic)
USE
(present) Private house
4. **IF MOVED, WHEN AND FROM WHERE:**

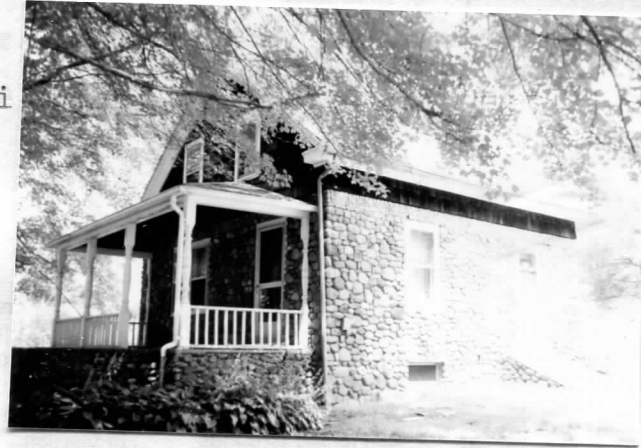
5. **ARCHITECT**
6. **DATE** c1925 **BUILDER** Probably Testori
STYLE
7. **ALTERATIONS**
Garage at rear.
8. **NOTABLE FEATURES**

9. **ARCHITECTURAL-HISTORICAL**
 This sort of masonry (rounded fieldstones or cobblestones of irregular shape and varied color set with the mortar deeply behind the front plane of the wall) had a vogue in the early part of the 20th century--part of the effort to rediscover, and re-identify with, nature at a time when people were beginning to realize that nature was disappearing. Although weathered brown shingles and spacious open porches were supposed to relate to country life, the style made itself at home in many an American small town. Here is a classic version.
