State of Connecticut  
**CONNECTICUT HISTORICAL COMMISSION**  
59 South Prospect Street, Hartford 06106

**HISTORIC RESOURCES INVENTORY:**  
Buildings & Structures

**SURVEY OF GUILFORD, NEW HAVEN COUNTY, 06437**  
June-December 1981

1. ADDRESS 3654 Durham Road  
(map 114, lot 22)
2. NAME  
(historic)  
NAME  
(common)
3. USE  
(historic) Farm  
USE  
(present) Private house, farm
4. IF MOVED, WHEN AND FROM WHERE:

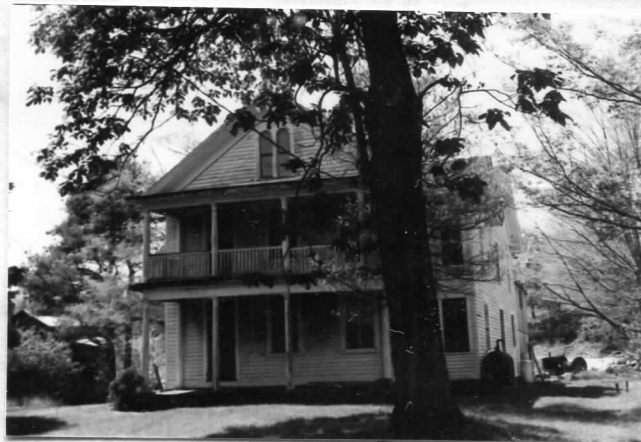
5. ARCHITECT
6. DATE c1850
- BUILDER  
STYLE Italianate
7. ALTERATIONS  
Much added onto: a two-story wing with a second gable on the north, another wing at the rear which seems to have once been a barn, and a double-decker porch across the front.
8. NOTABLE FEATURES  
Boxed cornice with returns; wide frieze; 2/2 sash; double arch windows in the gable; two-story porch with round columns; original door (copies the arched windows in the gable); large block foundation; wood storage shed attached to rear still intact.

Alterations: The wing was increased to two-storey  
in 1905. Later a side porch was  
enclosed.
