**HISTORIC RESOURCES INVENTORY:**  
Buildings & Structures

**SURVEY OF GUILFORD, NEW HAVEN COUNTY, 06437**  
June-December 1981

1. ADDRESS 4365 Durham Road  
(map 122, lot 24)
2. NAME  
(historic) Joseph Clark  
NAME  
(common)
3. USE  
(historic)  
USE  
(present) Private house
4. IF MOVED, WHEN AND FROM WHERE:

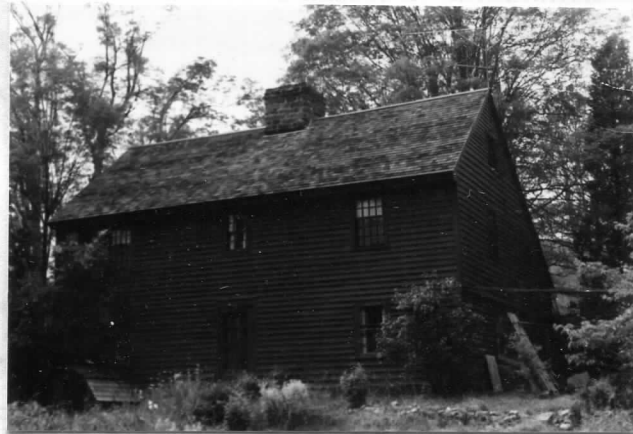
GLFD NEG 2:17

8. NOTABLE FEATURES  
8/12 sash. Large stone chimney may have been rebuilt but is evidently in original position with original number of flues.

A stark facade, with few windows--small and far apart. This house has the severity of the early 18th century. There is no extraneous material here. All window and door frames are as plain as possible. Now painted dark brown, it evokes the dark, weathered look of an early farmhouse and a time when life was harsh and insecure, and strangers were not always to be trusted.

15. CONDITION: Exterior

| <input checked="" type="checkbox"/> Excellent | <input type="checkbox"/> Good | <input type="checkbox"/> Fair | <input type="checkbox"/> Poor | <input type="checkbox"/> Bad |
