HISTORIC RESOURCES INVENTORY:
Buildings & Structures

SURVEY OF GUILFORD, NEW HAVEN COUNTY, 06437
June-December 1981

1. ADDRESS 5000 Durham Road
(map 128, lot 1)
2. NAME
(historic) Samuel Russell II
NAME
(common) Bluff Head Farm
3. USE
(historic)
USE
(present) Private house and farm
4. IF MOVED, WHEN AND FROM WHERE:

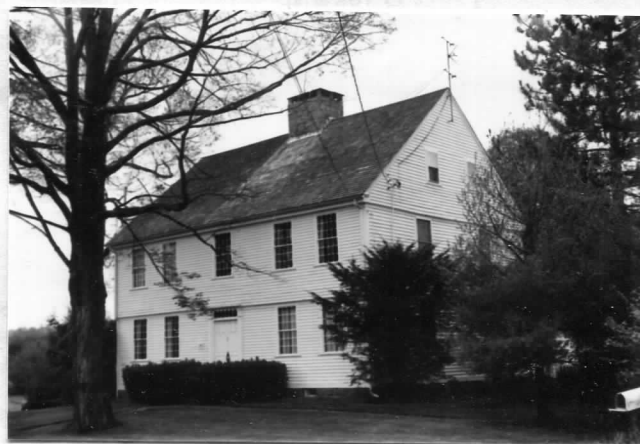
GLFD NEG 2:21

9. ARCHITECTURAL-HISTORICAL
With overhangs on front and sides; with 12/12 sash, a foundation of cut brownstone blocks, and a fine two-leaved door with iron latch and a six-light transom, this is one of Guilford's outstanding houses--well preserved, with clapboards, with window frames still intact, cedar shingles on the roof, and the chimney apparently rebuilt but still in its original form. Barns out back, pastures and fields around it, and ancient maple trees along the road complete the picture.

Notable Features: Overhangs, front and side; windows
and front door.
