HISTORIC RESOURCES INVENTORY:
Buildings & Structures

SURVEY OF GUILFORD, NEW HAVEN COUNTY, 06437
June-December 1981

1. ADDRESS 146 Elm Street
(map 105, lot 10)
2. NAME Theophilus Rossiter
NAME
(common)
3. USE Private house
(historic)
USE
(present)
4. IF MOVED, WHEN AND FROM WHERE:

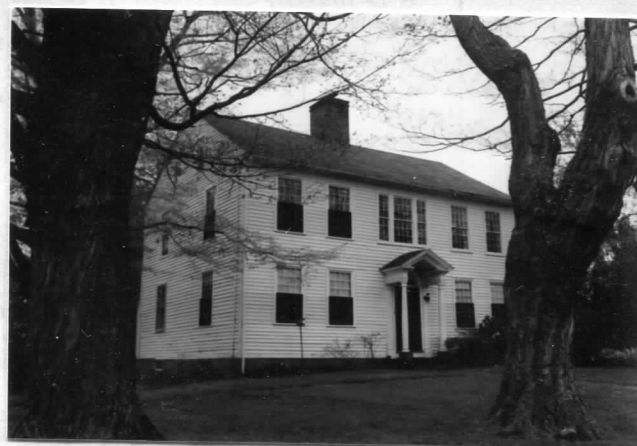
5. ARCHITECT
6. DATE Given variously as 1760 and c1810 BUILDER
STYLE Federal
7. ALTERATIONS
Shed addition in rear; side addition; brick chimney (rebuilt).

8. NOTABLE FEATURES Eave with moulding below; row of dentils and mutules decorate the eaves and porch hood; 12/12 sash; 6/6 sash in gable; entry with a pediment hood supported by slender columns and a semi-circular fanlight over the door; Palladian-like window; red stone (dressed) foundation.
