**HISTORIC RESOURCES INVENTORY:**  
 Buildings & Structures

**SURVEY OF GUILFORD, NEW HAVEN COUNTY, 06437**  
 June-December 1981

1. ADDRESS 33 and 37 Fair Street  
(map 39, lot 28)
2. NAME  
 (historic) Mehitabel and Anna  
 NAME Fowler  
 (common)
3. USE  
 (historic)  
 USE  
 (present) Private house and  
 apartment
4. IF MOVED, WHEN AND FROM WHERE:

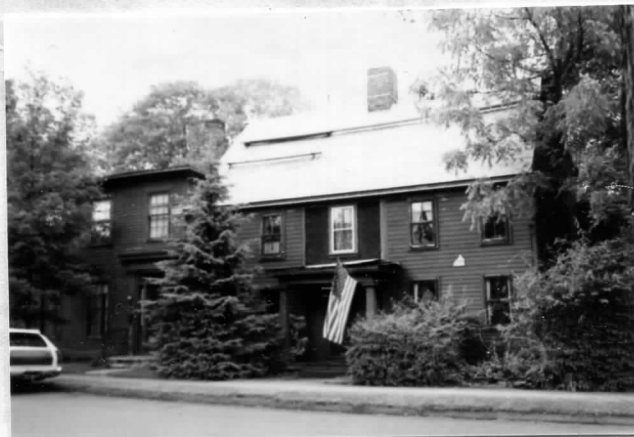
At some point in the mid-19th century the house was thoroughly altered and turned into a Downingesque cottage with overhanging eaves and a central gable ornamented with an arched window. Probably soon afterward a bay window was added to the middle of the front, and later still a severe squarish entry porch. To top off this complex history, a second house--evidently a rather plain Italian villa like the ones still standing at the bottom of the street--was moved up and somewhat incongruously attached to the north side; this too in due course acquired a large square entry porch. Across the front of the property a handsome fence like the ones still standing on Broad Street tied it all together. This is a remarkable history, but it is not done yet. Now, in 1982, the Victorian house is being re-Colonialized.

10. SOURCES Gable, overhanging eaves, arched window, polygonal bay, and north porch are gone, but the attached villa so far remains. The fence disappeared some time ago.
