HISTORIC RESOURCES INVENTORY:
Buildings & Structures

SURVEY OF GUILFORD, NEW HAVEN COUNTY, 06437
June-December 1981

1. ADDRESS 58 Fair Street
(map 39, lot 23)
2. NAME
(historic) Nathaniel Johnson
NAME
(common)
3. USE
(historic)
USE
(present) Private house
4. IF MOVED, WHEN AND FROM WHERE:

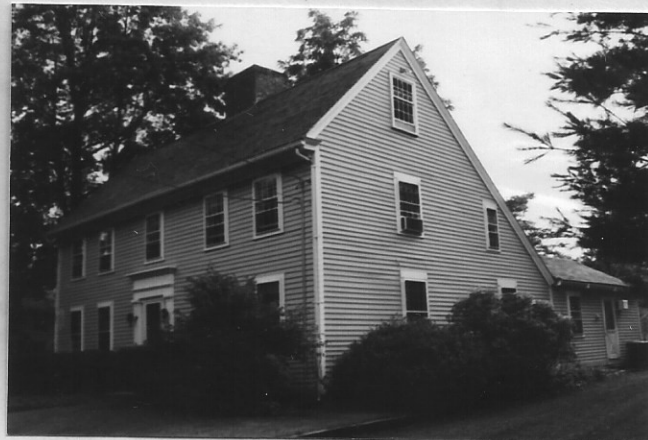
5. ARCHITECT
6. DATE 1730 BUILDER
STYLE Colonial
7. ALTERATIONS
Rebuilt chimney; Greek Revival doorway; addition to the rear.

8. NOTABLE FEATURES
Overhanging eaves with a boxed cornice; 8/12 sash on the second story and 12/12 sash on the first floor.
9. ARCHITECTURAL-HISTORICAL The wide overhang and the steep roof are characteristic of Guilford houses of the early part of the eighteenth century. This substantial house and its location on one of the village's important streets reflect the prominence of its builder, Nathaniel Johnson. The Greek Revival doorway was added in the mid nineteenth century, something done frequently in Guilford.
