**HISTORIC RESOURCES INVENTORY:**  
 Buildings & Structures

**SURVEY OF GUILFORD, NEW HAVEN COUNTY, 06437**  
 June-December 1981

1. ADDRESS 6 Fair Street  
(map 39, lot 17)
2. NAME  
(historic) Judge Nathaniel Griffing  
NAME  
(common)
3. USE  
(historic)  
USE  
(present) Private house
4. IF MOVED, WHEN AND FROM WHERE:

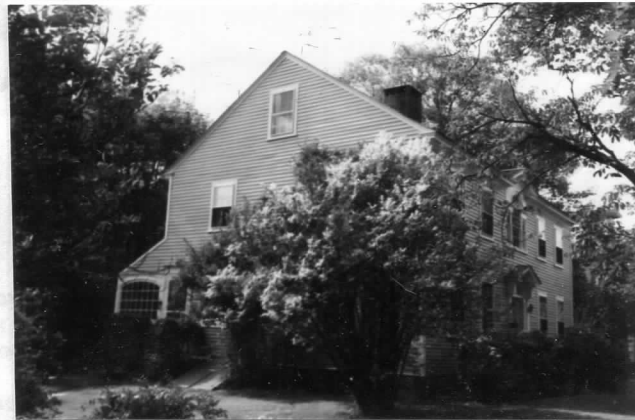
5. ARCHITECT
6. DATE 1807 BUILDER STYLE Federal
7. ALTERATIONS  
Window sash, possibly a new chimney, rear addition for sun room. The rear addition was built with the materials taken from Caleb Dudley I house on Clapboard hill.
8. NOTABLE FEATURES Palladian window with a pediment above projecting slightly above the roof line; original paneled double door; door hood over entrance; fanlight; cut stone field foundation.

9. ARCHITECTURAL-HISTORICAL This house occupies an important corner in the Guilford Village (Fair and Broad Street); pediment/palladian window an uncommon feature in Federal style houses in Guilford. It is part of an important collection of 18th and 19th century houses on Fair Street.  
Nathan Griffing, a leading citizen, built this house, copying that of his brother, Ephraim Joel, at 64 Fair Street, on land originally held by Robert Kitchel, a member of the Whitfield Company.  
A graduate of Yale College 1786, Griffing was Justice of the New Haven Colony Court for many years. He was active in town affairs; involved in the planning and fund-raising for the construction of the First Congregational Church built to replace the decaying meeting house on the Green. His widow, Sarah, deeded land on North Fair Street and gave \$10,000 for the establishment of a secondary school, The Guilford Institute.
