HISTORIC RESOURCES INVENTORY:
Buildings & Structures

SURVEY OF GUILFORD, NEW HAVEN COUNTY, 06437
June-December 1981

1. ADDRESS 77 Fair Street
(map 46, lot 31)
2. NAME
(historic) John Collins/Stephen Spencer
NAME
(common)
3. USE
(historic)
USE
(present) Private house
4. IF MOVED, WHEN AND FROM WHERE:

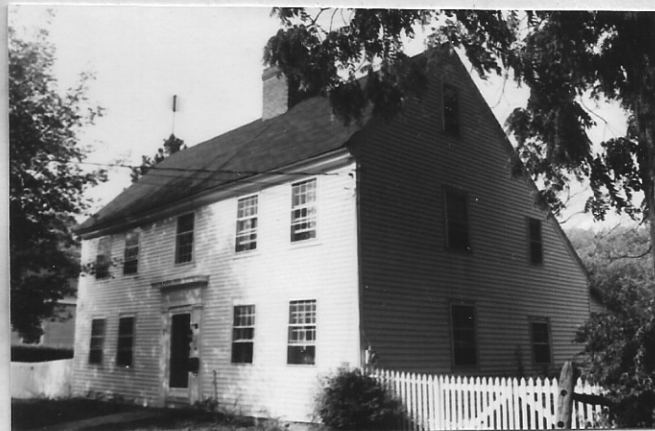
5. ARCHITECT
6. DATE 1727 / 1670 (chimney) BUILDER
STYLE Colonial
7. ALTERATIONS
Addition to the rear north portion of the house (has a stone foundation); rear porch; rebuilt chimney.

8. NOTABLE FEATURES
Boxed cornice with a moulding below; 8/12 sash (except in the gable and the second story lean-to portion which are 6/6 sash); Greek Revival doorway with a wide frieze and wide projecting cornice.
9. ARCHITECTURAL-HISTORICAL Economically built around a chimney dating from 1670, this two-story house has a five bay facade. The house has a one room deep plan with a lean-to addition. Like many other Colonial houses in Guilford, this one was updated with a Greek Revival entryway. The house is located on Fair Street along with several other architecturally important houses.
John Collins came to Guilford in 1669. The following year the Town meeting gave him permission to buy this property from John Stevens. Stephen Spencer, a blacksmith who settled in Guilford in 1724, bought the house in 1726 and lived here until 1737.
