HISTORIC RESOURCES INVENTORY:
 Buildings & Structures

SURVEY OF GUILFORD, NEW HAVEN COUNTY, 06437
 June-December 1981

1. ADDRESS 78 Fair Street
(map 46, lot 35)
2. NAME
(historic) Joseph Chittenden
NAME
(common)
3. USE
(historic)
USE
(present) Private house
4. IF MOVED, WHEN AND FROM WHERE:

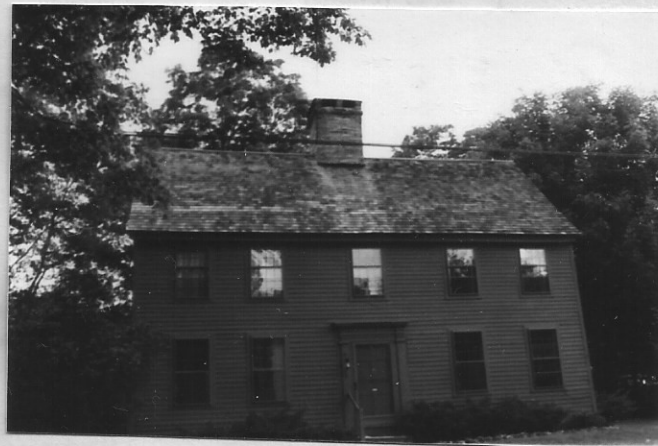
5. ARCHITECT
6. DATE 1766
- BUILDER
STYLE Colonial
7. ALTERATIONS
Rear ell and a small addition on the north side; Greek Revival doorway added by current owner.
8. NOTABLE FEATURES
Stone chimney; 12/12 sash on the front first floor and 8/12 sash on the second floor; boxed cornice with a moulding below.

9. ARCHITECTURAL-HISTORICAL An excellent example of mid 18th century architecture; in a fine state of preservation, and part of an important collection of 18th and 19th century houses on Fair St. This five bay two-story Colonial House is located on Fair Street with several other 18th and 19th century homes. The outline of a pediment is visible on the clapboards above the Greek Revival doorway which was added by the current owners.
