HISTORIC RESOURCES INVENTORY:
 Buildings & Structures

SURVEY OF GUILFORD, NEW HAVEN COUNTY, 06437
 June-December 1981

1. ADDRESS 84 Fair Street
(map 46, lot 36)
2. NAME Edwin A. Leete
(historic)
NAME
(common)
3. USE
(historic)
USE Private house
(present)
4. IF MOVED, WHEN AND FROM WHERE:

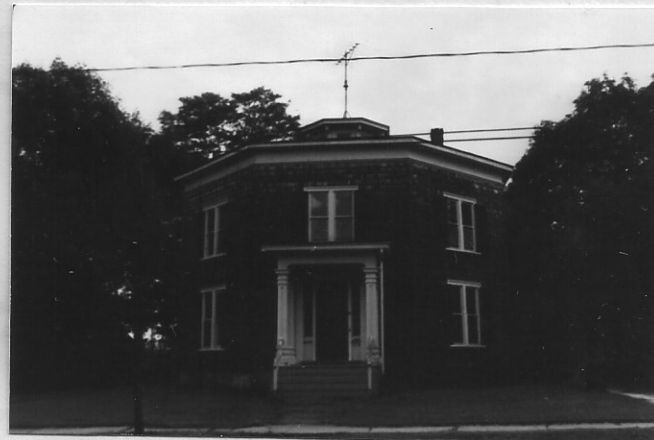
5. ARCHITECT
6. DATE 1856
- BUILDER
- STYLE Octagonal Villa
7. ALTERATIONS Present brown shingles may be laid over original clapboards, sinking the window trim into the plane of the wall.

8. NOTABLE FEATURES The octagon had a brief bloom in the 1850s. Though widely popularized, it remained exceptional, and not many are now left. This is the only substantial one in the New Haven area known today.

9. ARCHITECTURAL-HISTORICAL The Octagonal Villa was the brain child of an eccentric phrenologist named Orson Squire Fowler, who believed that the form was conducive to health and marital happiness and who wrote a book about it called A Home for All.... Characteristics of the type are the monitor on the roof, lighting and ventilating the central hall around which all the rooms revolve, and Italianate ornament and broad eaves. Usually either a porch runs all around the building or there is a balcony under each window: both are devices for carrying the eye around the form and seeing it in the round. The Leete house has a barer look than is usual, and it is possible that some such trim has been stripped also that the eaves have been clipped.
