HISTORIC RESOURCES INVENTORY:
 Buildings & Structures

SURVEY OF GUILFORD, NEW HAVEN COUNTY, 06437
 June-December 1981

1. **ADDRESS** 85 Fair Street
(map 46, lot 30)
2. **NAME**
 (historic) North West Center School
NAME
 (common)
3. **USE**
 (historic) School House
USE
 (present) Private house
4. **IF MOVED, WHEN AND FROM WHERE:**

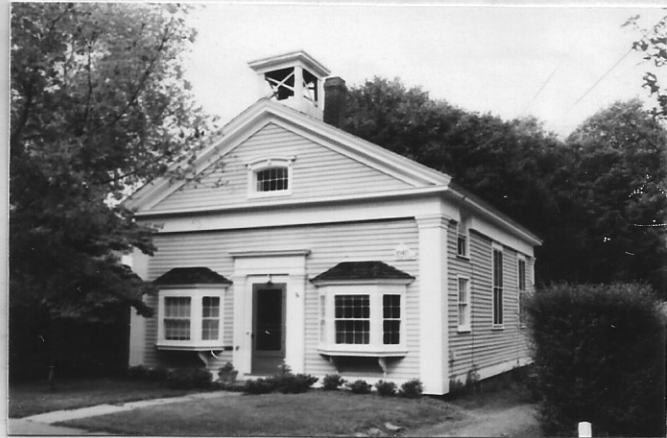
5. **ARCHITECT**
6. **DATE** 1848 **BUILDER**
STYLE Greek Revival
7. **ALTERATIONS**
 Two front bay windows; second "floor" windows; frieze on both sides of building.
8. **NOTABLE FEATURES**
 Strong pediment; large corner pilasters; Greek Revival door frame; wide frieze; a slightly arched gable window; bellfry.

9. **ARCHITECTURAL-HISTORICAL** The North West Central School is one of the strongest Greek Revival buildings in Guilford. One of the most notable features is the wide corner pilasters which are rare in Guilford. The school has a full pediment and very wide frieze board. A square, flat topped bellfry sits near the front of the building. Little appears to have changed in comparison to an early photograph (c1880); the gable window was originally a vent and the doorway had a portico. There were no windows where the modern bay windows are now located.
 Built in 1848, students from this district of the Town's center attended this one-room school until 1871 when several schools were consolidated into the Union School District. (continued)

Originally set further back from the street the building was moved closer to Fair Street at one time. The few changes which have been made to adapt it for use as a private house have not impaired its identity as a school of the Greek Revival period.
