HISTORIC RESOURCES INVENTORY:
Buildings & Structures

SURVEY OF GUILFORD, NEW HAVEN COUNTY, 06437
June-December 1981

1. ADDRESS 96 Fair Street
2. NAME
(historic) Abraham Woodward
NAME
(common)
3. USE
(historic)
USE
(present) Private house
4. IF MOVED, WHEN AND FROM WHERE:

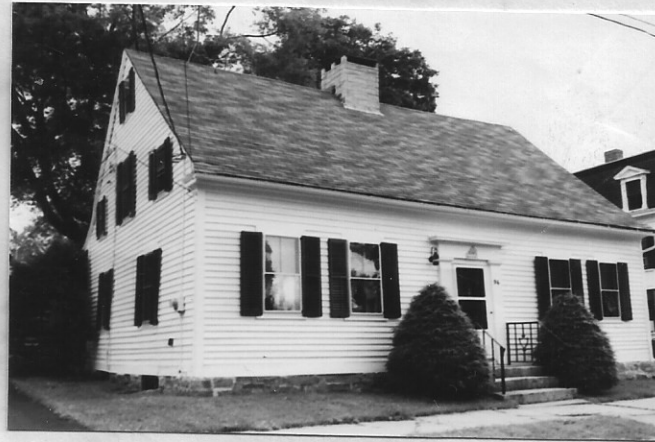
5. ARCHITECT 1785
6. DATE
- BUILDER
STYLE Colonial
7. ALTERATIONS
First floor windows, flooring material; chimney rebuilt; front steps and railings.

8. NOTABLE FEATURES
Boxed cornice with a moulding below, 12/12 sash on the second floor and small six over six windows in the garret and below the sloping portion of the second floor; rear roof curves near eave line; Greek Revival entrance; field stone foundation.
9. ARCHITECTURAL-HISTORICAL
A typical example of a story and a half Colonial house, with a Greek Revival entrance.
This house was owned by Edwin A. Leete (see 98 Fair Street and 1090 Boston Post Road). It is still occupied by the widow of Earl B. Leete (1982). Prior to Leete ownership the land changed hands many times -
