**HISTORIC RESOURCES INVENTORY:**  
Buildings & Structures

**SURVEY OF GUILFORD, NEW HAVEN COUNTY, 06437**  
June-December 1981

1. ADDRESS 98 Fair Street  
(map 46, lot 39)
2. NAME Edwin A. Leete  
(historic)  
NAME  
(common)
3. USE Private house and  
(historic)  
USE Funeral parlor  
(present) Private house and shops
4. IF MOVED, WHEN AND FROM WHERE:

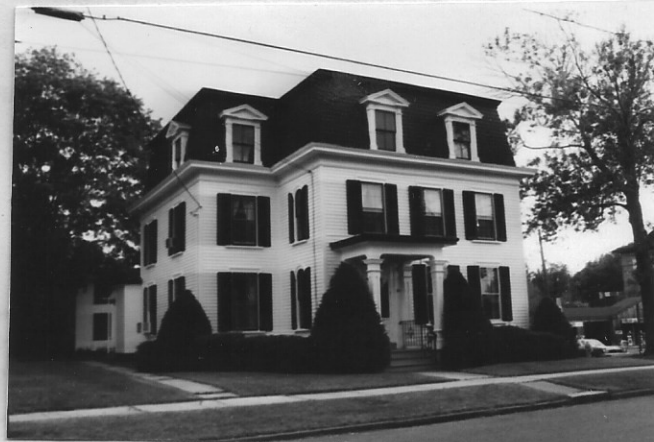
5. ARCHITECT
6. DATE 1869-1870
- BUILDER  
STYLE Second Empire
7. ALTERATIONS  
Asphalt shingles on roof; addition to rear; wrought iron railing on front steps.

Arched windows on south side of house; triangular pediment on dormer windows; 6/6 sash; wide overhanging eaves; square columns with recessed panels on entryway.

This house is a very simple Second Empire structure and it almost appears as if the mansard roof was added to an existing Italian Villa. However, the records seem to indicate that the roof is original, and it does appear on the 1881 birdseye view maps of Guilford.
