HISTORIC RESOURCES INVENTORY:
Buildings & Structures

SURVEY OF GUILFORD, NEW HAVEN COUNTY, 06437
June-December 1981

1. ADDRESS 184 Falcon Road
(map 1, lot 59)
2. NAME
(historic) George B. Wingood
NAME
(common)
3. USE
(historic)
USE
(present) Private house
4. IF MOVED, WHEN AND FROM WHERE:

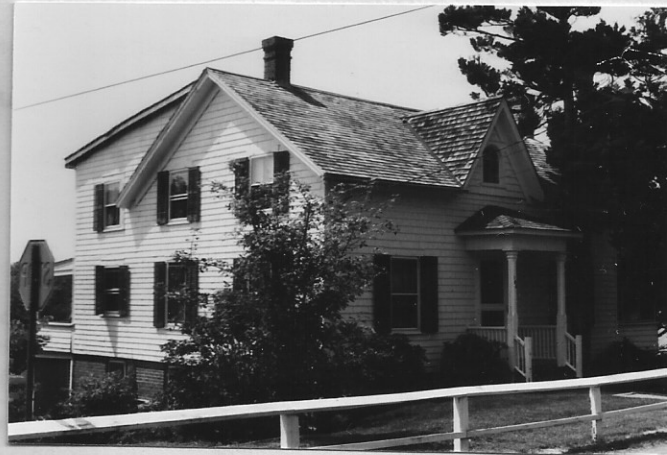
Negative ROLL 19:3

5. ARCHITECT
6. DATE 1878 BUILDER
STYLE Vernacular
7. ALTERATIONS
Shingle siding; large rear addition (altering rear roof line).
8. NOTABLE FEATURES
Center gable with an arched window; modest front porch with large dentils under the eaves; brick foundation.
9. ARCHITECTURAL-HISTORICAL
A peaked gable with an arched window over the doorway is a picturesque touch on the facade of this house. When a rear addition providing much space was built, the old gable line was retained on the side, a reminder of the house's original shape. This is one of the early cottages on Sachem's Head.
