HISTORIC RESOURCES INVENTORY:
 Buildings & Structures

SURVEY OF GUILFORD, NEW HAVEN COUNTY, 06437
 June-December 1981

1. ADDRESS 135 Goose Lane
(map 75, lot 11)
2. NAME
(historic) William Dudley
NAME
(common)
3. USE
(historic)
USE
(present) Doctor's offices
4. IF MOVED, WHEN AND FROM WHERE:

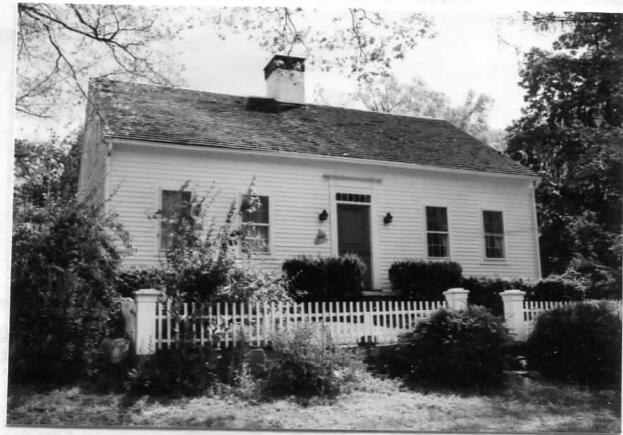
5. ARCHITECT
6. DATE 1806 BUILDER
STYLE Federal
7. ALTERATIONS
Addition to the rear; fenestration altered on the side.

8. NOTABLE FEATURES
Slightly overhanging eaves with a moulding below; 6/6 sash; doorway with a six pane transom, and an architrave trim above the transom; field stone foundation.
9. ARCHITECTURAL-HISTORICAL
This is a well-proportioned house of the Federal period. The central doorway has an interesting treatment with a transom surmounted by architrave trim suggesting capitals. A very similar doorway is found at 246 Goose Lane. A stone embankment and picket fence surround a lawn that makes a fine setting for one of Guilford's smaller houses of the Federal period.
William Dudley, one of the sons of Amos Dudley the builder, built this house. Deacon Richard Bartlett once lived here as did Ayres Stevens, a basketmaker
