HISTORIC RESOURCES INVENTORY:
 Buildings & Structures

SURVEY OF GUILFORD, NEW HAVEN COUNTY, 06437
 June-December 1981

1. ADDRESS 246 Goose Lane
(map 75, lot 1)
2. NAME
(historic) Timothy Seward, Jr.
NAME
(common)
3. USE
(historic)
USE
(present) Private house
4. IF MOVED, WHEN AND FROM WHERE:

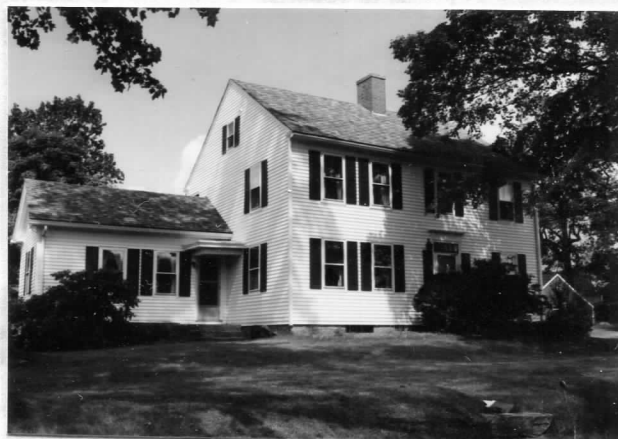
5. ARCHITECT
6. DATE 1817 BUILDER STYLE Federal
7. ALTERATIONS
Side addition (built before 1900); second floor added to the rear ell (c1908); siding; chimney; 2/2 sash.
8. NOTABLE FEATURES
Doorway; five pane transom (the same trim as on 135 Goose Lane door; an architrave trim above the transom, (

9. ARCHITECTURAL-HISTORICAL
 With two bays on one side of the doorway and one on the other, this house has an asymmetrical facade not found in most of the town's larger Federal houses. The doorway with suggestions of capitals over a transom is like that at 135 Goose Lane. This house is part of a farm with several outbuildings.
 Timothy Seward Jr. married Sarah Bartlett. Carter family bought this house from Seward family in 1840. A William Chittenden is reputed to have built this house. He is also said to have rebuilt the house at 333 Goose Lane.
