**HISTORIC RESOURCES INVENTORY:**  
 Buildings & Structures

**SURVEY OF GUILFORD, NEW HAVEN COUNTY, 06437**  
 June-December 1981

1. ADDRESS 749 Goose Lane  
(map 81, lot 20)
2. NAME  
(historic) George Dibble  
NAME  
(common)
3. USE  
(historic)  
USE  
(present) Private house
4. IF MOVED, WHEN AND FROM WHERE:

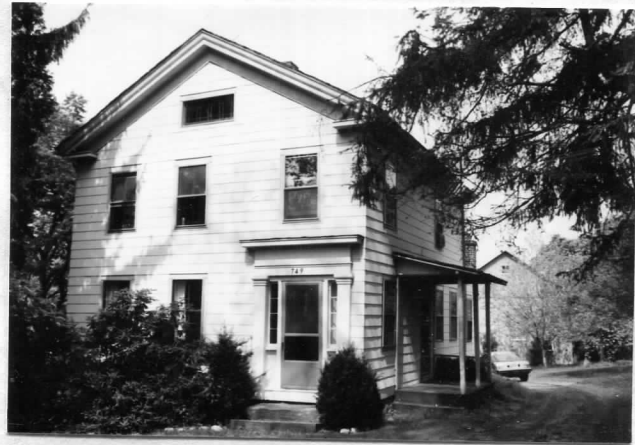
5. ARCHITECT
6. DATE c1842 BUILDER STYLE Greek Revival
7. ALTERATIONS  
Siding; 2/2 sash; outside chimney.

8. NOTABLE FEATURES  
Boxed cornice with returns; rectangular gable window; doorway with pilasters; entablature and sidelights.
9. ARCHITECTURAL-HISTORICAL  
The irregular window placement of this house is most unusual for houses of its style. The house has a wide doorway with sidelights, pilasters, and an entablature with dentils. George A. Dibble was the first owner of this house built on the site of an earlier house belonging to his grandmother Mindwell Stone Dibble.
