HISTORIC RESOURCES INVENTORY:
 Buildings & Structures

SURVEY OF GUILFORD, NEW HAVEN COUNTY, 06437
 June-December 1981

1. ADDRESS 789 Goose Lane
(map 81, lot 19)
2. NAME (historic) Joel Evarts
NAME (common)
3. USE (historic)
USE (present) Private house
4. IF MOVED, WHEN AND FROM WHERE:

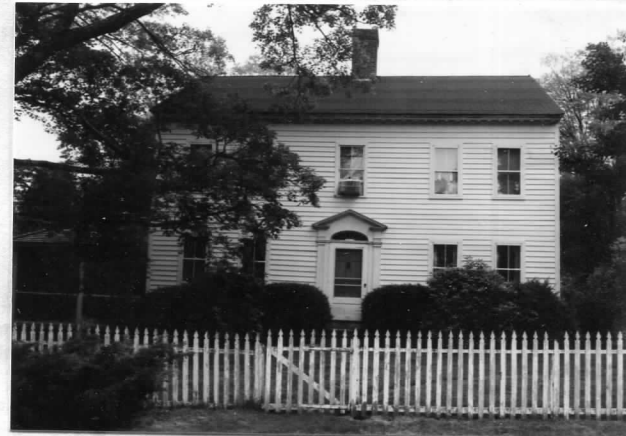
5. ARCHITECT
6. DATE 1830-31 BUILDER STYLE Federal
7. ALTERATIONS Side screened porch; 2/2 sash; brick chimney (appears to be too small to be original).
8. NOTABLE FEATURES

9. ARCHITECTURAL-HISTORICAL
 The facade of this house resembles its Colonial predecessors, but its detailing is Federal. A row of mutules and dentils trimming the eaves of this house are a noteworthy feature, as is the doorway with fluted pilasters, a small fanlight, and a triangular pediment. A fine fence of shaped pickets sets off the house.
 Joel Evarts built this house in 1830-31. The original bill of sale exists for this house. Joel Evarts married Clarissa Dudley, daughter of Abraham Dudley, Jr. of Clapboard Hill.
