**HISTORIC RESOURCES INVENTORY:**  
Buildings & Structures

**SURVEY OF GUILFORD, NEW HAVEN COUNTY, 06437**  
June-December 1981

1. ADDRESS 829 Goose Lane  
(map 87, lot 1)
2. NAME  
(historic) Col. George Foote  
NAME  
(common)
3. USE  
(historic)  
USE  
(present) Private house
4. IF MOVED, WHEN AND FROM WHERE: 1809

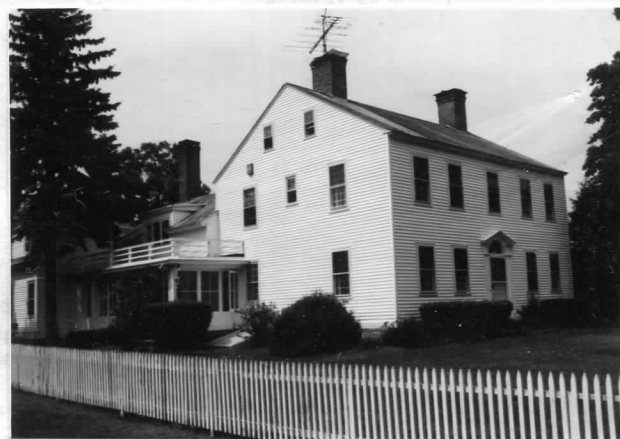
5. ARCHITECT
6. DATE 1810 BUILDER  
STYLE Federal
7. ALTERATIONS  
Large rear additions; solarium; siding.

8. NOTABLE FEATURES  
Central hall; two large brick chimneys; 12/12 sash; 6/6 sash in the gable; doorway with plain pilasters; triangular pediment, and a semi-circular fanlight; stone foundation.
9. ARCHITECTURAL-HISTORICAL  
Houses of twin-chimney central-hall type are unusual for Guilford, and this is a good example of the form. Windows with small panes and a doorway with a triangular pediment and a semicircular fanlight are major complements to the facade. Extensive additions stretch out behind the house. It sits amid a beautiful complex of buildings, pastures, and fields on a lawn surrounded by a picket fence. This large property is the principal feature of this rural district. (continued..)
