HISTORIC RESOURCES INVENTORY:
 Buildings & Structures

SURVEY OF GUILFORD, NEW HAVEN COUNTY, 06437
 June-December 1981

1. **ADDRESS** 23 Graves Avenue
(map 40, lot 37)
2. **NAME**
(historic) Sherman Graves
NAME
(common)
3. **USE**
(historic)
USE
(present) Private house, apartment
4. **IF MOVED, WHEN AND FROM WHERE:**
 The house was moved from the corner of Boston and Graves
 c1920.

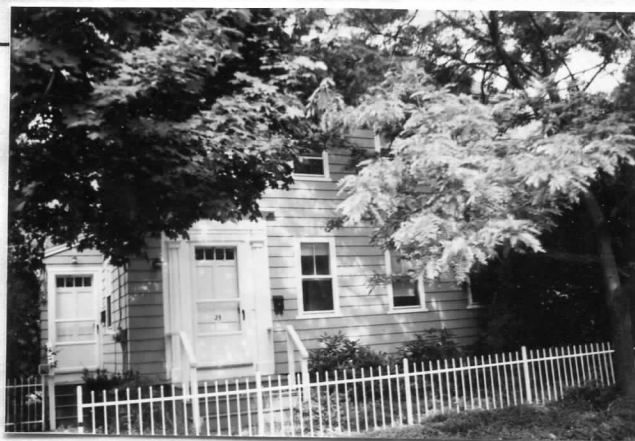
5. **ARCHITECT**
6. **DATE** 1825 **BUILDER** Federal
STYLE
7. **ALTERATIONS**
 Shingle siding; chimney; moved and placed on a brick foundation;
 2/2 sash.
8. **NOTABLE FEATURES**
 Overhanging of the third story; moulding under the eave; doorway
 with moulded pilasters, stylized entablature and a protruding
 moulding above.

9. **ARCHITECTURAL-HISTORICAL**
 Relief panels of the entablature carry the lines of the pilasters
 and capitals up to the cornice to produce an elegant doorway, a
 particularly fine feature of this house. The doorway is in the
 first bay of this well-proportioned four-bay house. Having been
 moved from the corner, this house is unusually early for this
 street; it stands in a neighborhood of later 19th century houses.
 Sherman Graves was a trustee of The Guilford Institute in
 1854. A Republican, he was a delegate from Guilford to the General
 Assembly in 1860.
