HISTORIC RESOURCES INVENTORY - BUILDING AND STRUCTURES

Building Name (Common) 131 Great Hill Road
 Building Name (Historic) David B. Rossiter House
 Street Address or Location 131 Great Hill Road
 Town/City Guilford Village _____ County New Haven
 Owner(s) Peter and Sandra Benzi Public Private

131 Great Hill Rd

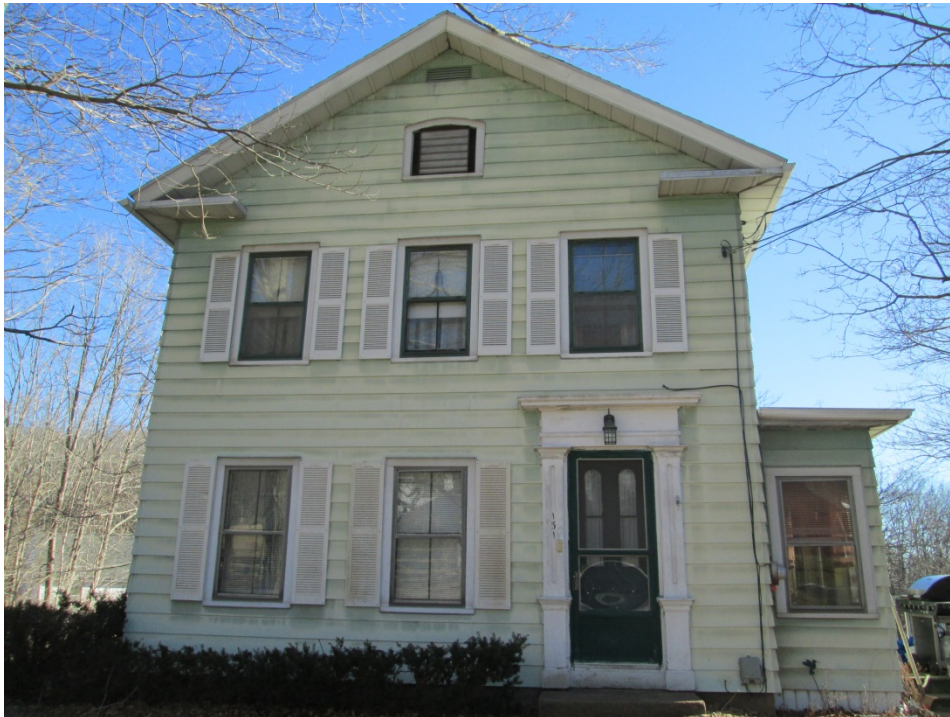
View West view of the house, camera facing east. Negative on File _____

The Greek Revival features include the door surround with pilasters and an entablature, the symmetry of the fenestration, and the overhanging eaves with cornice returns. Fenestration consists of two-over-two double-hung sash windows with shutters. An enclosed porch is on the south elevation and wraps around the east elevation.
