HISTORIC RESOURCES INVENTORY:
 Buildings & Structures

SURVEY OF GUILFORD, NEW HAVEN COUNTY, 06437
 June-December 1981

1. **ADDRESS** 134 Great Hill Road
(map 109, lot 16)
2. **NAME**
(historic) Benjamin Rossiter
NAME
(common)
3. **USE**
(historic)
USE
(present) Private house
4. **IF MOVED, WHEN AND FROM WHERE:**

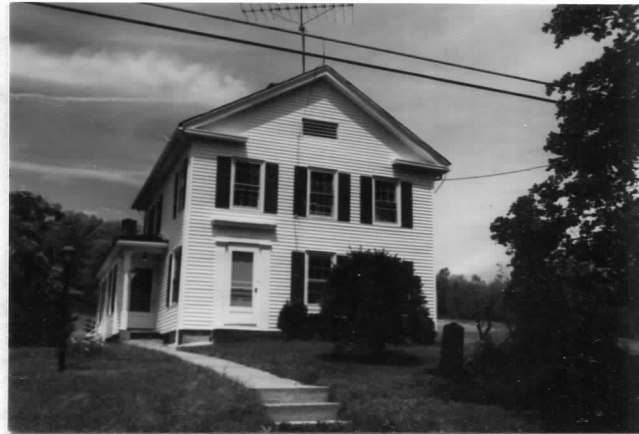
Guilford's Neg. P 3: 11A

5. **ARCHITECT**
6. **DATE** c1835 - See below **BUILDER**
STYLE Greek Revival
7. **ALTERATIONS**
Siding; gable window; carriage shed converted to two-car garage.

8. **NOTABLE FEATURES**
Long cornice returns; very simple Greek Revival doorway with an entablature and pilasters; 6/6 sash.
9. **ARCHITECTURAL-HISTORICAL**
The long returns on the cornice are an interesting variant of the Greek Revival form usually found in Guilford. This house with its agricultural outbuildings and farmland dominates its setting.
The date 1835, assigned to the house by The Dorothy Whitfield Society Survey, is disputed by the current owner who inherited the property from the Rossiter family. The owner believes the date of this house is earlier than 1835. This house and the one across the road at 99 Great Hill are believed to have been constructed by Rossiter or the same builder. This house is, however, not sheathed whereas the house at 99 is (perhaps built at a later time). It is said that the house was moved 150 yards north from its original site, at one time.
