HISTORIC RESOURCES INVENTORY:
Buildings & Structures

SURVEY OF GUILFORD, NEW HAVEN COUNTY, 06437
June-December 1981

1. ADDRESS 405 Great Hill Road
(map 113, lot 20)
2. NAME
(historic) Austin Fowler
NAME
(common)
3. USE
(historic)
USE
(present) Private house
4. IF MOVED, WHEN AND FROM WHERE:

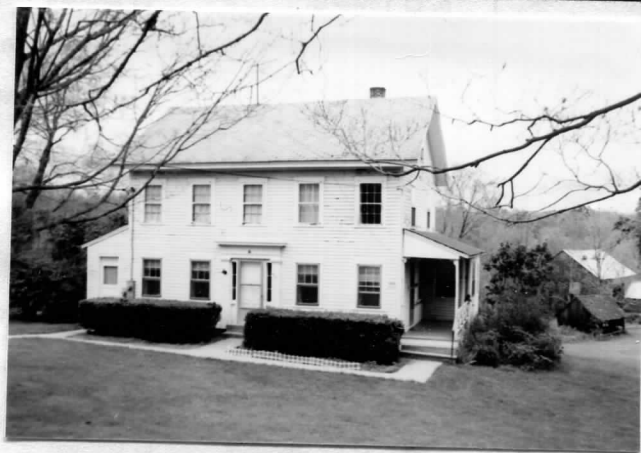
5. ARCHITECT
6. DATE pre-1852
- BUILDER
STYLE Greek Revival--see below
7. ALTERATIONS
Side shed addition; side porch.

Wide overhanging eaves; boxed cornice; 6/6 sash; Doric doorway with an entablature, pilasters and sidelights.

Architecturally a puzzling building: Late Colonial in outline with a Greek Revival door. This in itself would not be unusual for c1850 in Guilford where the basic Colonial tradition hung on far into the 19th century and was often combined with Greek Revival ornament and details. But here the height of the stories and the big barnlike roof with untrimmed edges seem far removed from the earlier work. Possibly the roof has been rebuilt. All that we know is that a house is shown on this site on a map of 1852.
