HISTORIC RESOURCES INVENTORY:
Buildings & Structures

SURVEY OF GUILFORD, NEW HAVEN COUNTY, 06437
June-December 1981

1. ADDRESS 976 Great Hill Road
(map 121, lot 1 see map 117)
2. NAME
(historic) Ira Kimberly
NAME
(common)
3. USE
(historic)
USE
(present) Private house
4. IF MOVED, WHEN AND FROM WHERE:

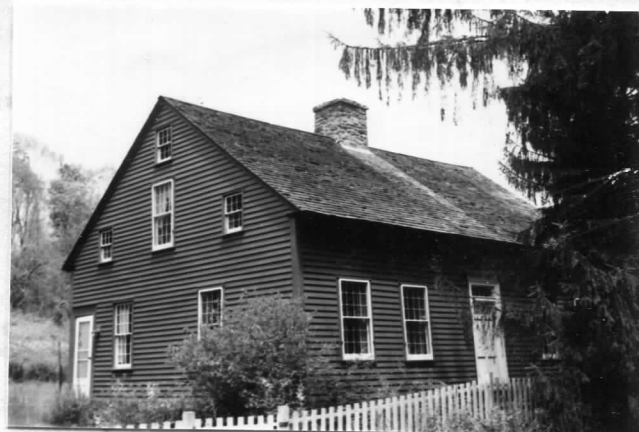
5. ARCHITECT
 6. DATE 1824
 7. ALTERATIONS
- BUILDER
STYLE Colonial

8. NOTABLE FEATURES
Overhanging eaves decorated with a moulding; 12/12 sash except in the garret and the second floor windows; doorway with five pane transom and a small entablature above; panel door; window and the doorway reproduced from the deteriorated originals; stone chimney rebuilt.
9. ARCHITECTURAL-HISTORICAL
Wood shingled roof, stone chimney, small-paned windows, and transom-lighted doorway are all fine features of this house. The excellent condition of this house is the result of careful restoration and reconstruction of these features based on materials found in the house. This is a good example of the small cottage-form houses of the Federal period.
Ira Kimberly, a mechanic, was assessed twelve cents tax by the North Guilford Congregational Church Society for the year 1811 and 1812. He built this house for his bride, Nabby Scranton.

15. CONDITION: Exterior

☒ Good
