HISTORIC RESOURCES INVENTORY - BUILDING AND STRUCTURES

Building Name (Common) 23 High Street
 Building Name (Historic) Edwin Flook House
 Street Address or Location 23 High Street
 Town/City Guilford Village _____ County New Haven
 Owner(s) Sean Libby and Margot Ebling Public Private

23 High Street

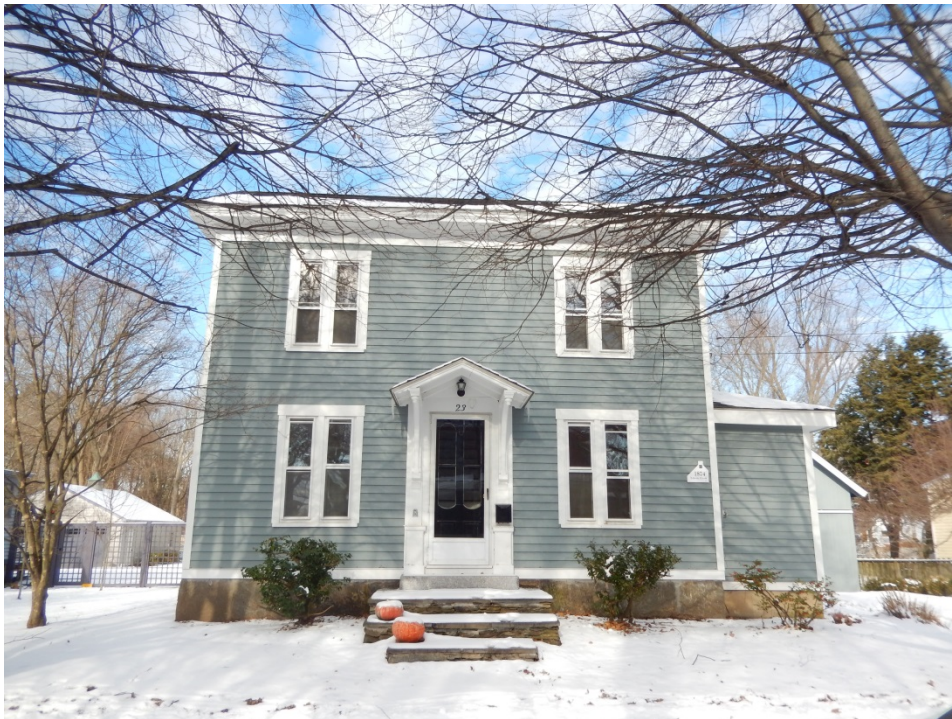
This is a two-story dwelling with a side-gable roof that has overhanging eaves. The house is Greek Revival in style and sheathed in clapboard siding. The roof is covered in asphalt shingles and the foundation is made of stone. The three-bay façade faces south, and the main entry is centered on this side. It is reached by stone steps and is protected from the elements by a gable-roof that is supported by decorative brackets. (See continuation sheet)

Photographer Kristen Nietering Date 6/27/2015
View South view of the house, camera facing north. Negative on File _____
Name Kristen Nietering Date 10/15/2015
Organization Guilford Preservation Alliance
Address 199 PO Box Guilford, CT 06437

The Greek Revival features include the overhanging eaves, the symmetrical façade, the wide fascia board, molding on the corners and bottom of the house, and the slightly decorative features of the window trim as well as the door surround. Fenestration consists of paired, slender one-over-one double-hung sash windows. Additions are on the north and east elevations of the house.
