**HISTORIC RESOURCES INVENTORY:**  
Buildings & Structures

**SURVEY OF GUILFORD, NEW HAVEN COUNTY, 06437**  
June-December 1981

1. ADDRESS 40 High Street  
(map 33, lot 79)
2. NAME  
(historic)  
NAME  
(common)
3. USE  
(historic)  
USE  
(present) Private house, apartment  
units
4. IF MOVED, WHEN AND FROM WHERE:

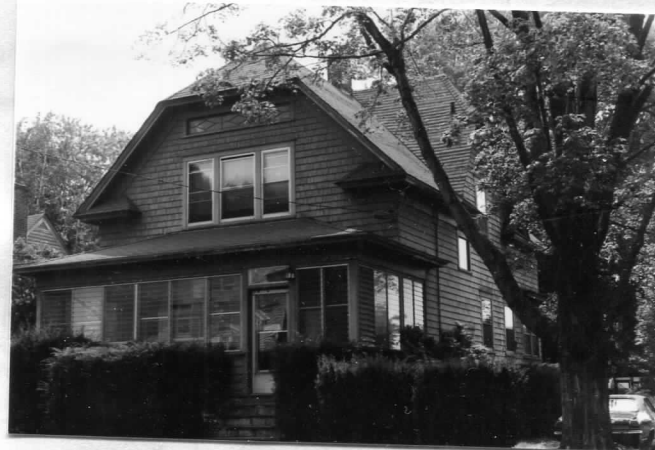
5. ARCHITECT
6. DATE Probably c1902
7. ALTERATIONS  
Aluminum windows; enclosed porch.
8. NOTABLE FEATURES  
Jerkinhead roof line; boxed cornice with modified returns; frieze;  
rectangular window in the gable with decorative leaded glass.

**BUILDER**  
**STYLE** Shingle style

The jerkinhead roof appears on several houses in Guilford. This nicely proportioned house is in keeping with the scale of its neighborhood. Although the porch has been enclosed, changing the overall look of the facade, the leaded glass window has been retained as a reminder of the original appearance of the house. A title search has proven inconclusive on this house, appearance points to a date in the early 20th century.
