**HISTORIC RESOURCES INVENTORY:**  
Buildings & Structures

**SURVEY OF GUILFORD, NEW HAVEN COUNTY, 06437**  
June-December 1981

1. ADDRESS 329 Lake Drive  
(map 114, lot 3)
2. NAME  
(historic) JOHN SCRANTON  
NAME  
(common)
3. USE  
(historic)  
USE  
(present) Private house
4. IF MOVED, WHEN AND FROM WHERE:

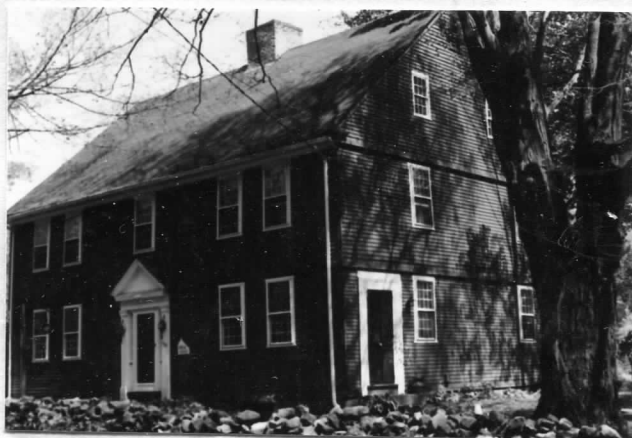
5. ARCHITECT
6. DATE 1789
- BUILDER  
STYLE Colonial
7. ALTERATIONS  
Brick chimney; addition in rear; doorway with slender pilasters; pediment with dentils, and sidelight.

8. NOTABLE FEATURES  
Overhangs along the front and sides delineate the floors of this center-chimney house. The high peaked pedimented doorway of the facade may be a later addition. A small side door is an unusual feature. The house is a good example of the larger Colonial build-
9. ARCHITECTURAL-HISTORICAL ings and one of the few 18th century houses in this part of Guilford.  
John Russell Scranton, son of Jared, and grandson of Ebenezer Scranton who settled in North Guilford, was the first owner of this house. All were farmers and descendants of John Scranton, a member of the Whitfield Company. It is said this house was a tavern when the nearby Rockland Road was the main route to Hartford.

Notable Features: The side door was built to protect  
the original coffin door which  
remains intact.
