HISTORIC RESOURCES INVENTORY:
Buildings & Structures

SURVEY OF GUILFORD, NEW HAVEN COUNTY, 06437
June-December 1981

1. ADDRESS 145 Ledge Hill Road
or Meeting House Hill
(map 109, lot 12)
2. NAME
(historic)
NAME North Guilford Congrega-
(common) tional Church Parsonage
3. USE
(historic)
USE
(present) Parsonage
4. IF MOVED, WHEN AND FROM WHERE:

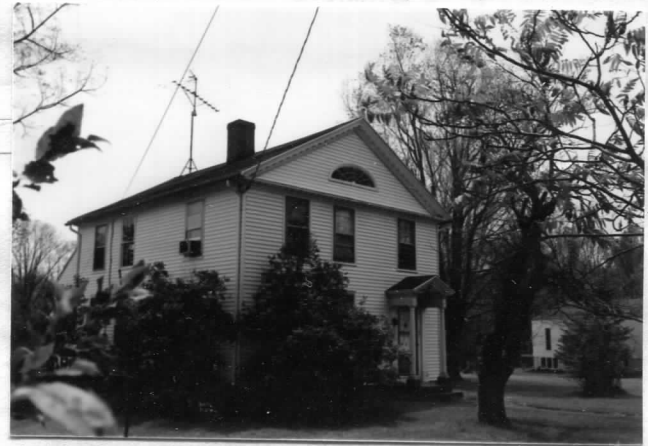
5. ARCHITECT See below
6. DATE c1820
7. ALTERATIONS
Siding; side wing and rear shed addition (late 19th century).

8. NOTABLE FEATURES
Mutules and dentils in delicate cornice and door hood; elliptical fanlight in gable and fanlight over door; asymmetrical fenestration; and red stone block foundation with no mortar. Possibly the work of Abraham Coan: see the Congregational Church.
