HISTORIC RESOURCES INVENTORY:
 Buildings & Structures

SURVEY OF GUILFORD, NEW HAVEN COUNTY, 06437
 June-December 1981

1. ADDRESS 159 Ledge Hill Road or Meeting House Hill (map 109, lot 12)
2. NAME
 (historic) North Guilford Congregational
 NAME Church
 (common)
3. USE
 (historic) Church
 USE Church
 (present)
4. IF MOVED, WHEN AND FROM WHERE:

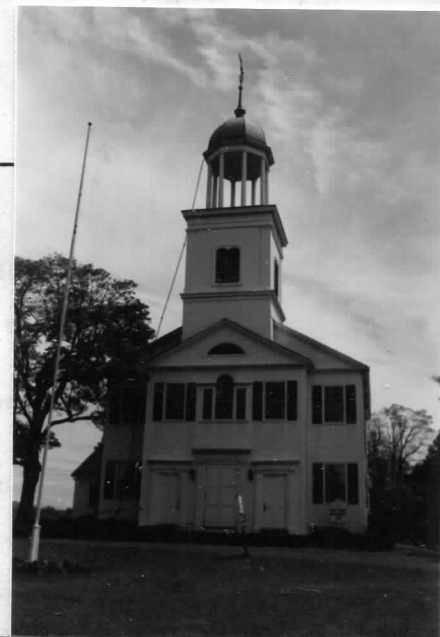
One of Guilford's major productions of the Federal period, distinguished for delicacy of ornament and for a nicely proportioned facade with a trio of doors, all with flat entablatures whose slim horizontal cornices are repeated in that of the Palladian window above.

The steeple is puzzling. In style it seems markedly different from the rest--heavier, plainer, and rather clumsy ("Greek Revival" says Kelly, which to him is a term of disapproval), and yet a steeple is mentioned as early as 1816 and in 1827 a bell is hung in what can only be a belfry.
