SURVEY OF GUILFORD, NEW HAVEN COUNTY, 06437
June-December 1981

| IDENTIFICATION | 169 Ledge Hill Road or Meeting House Hill (map 109, lot 12) | | |
| 2. NAME (historic) NAME (common) | Congregational Parish Hall | | |

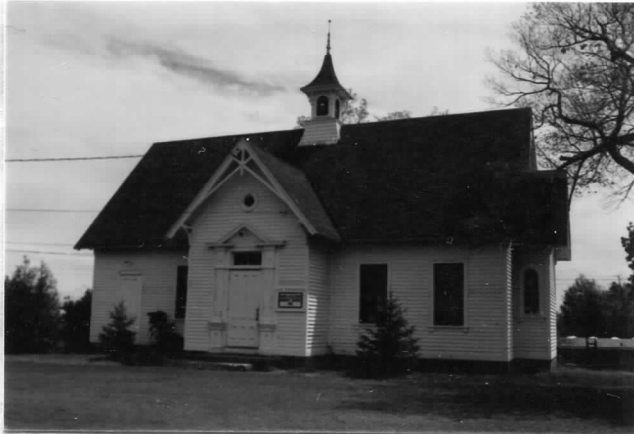
| IDENTIFICATION | 169 Ledge Hill Road or Meeting House Hill (map 109, lot 12) | | |
|---|--|---|--|
| DESCRIPTION | 8. NOTABLE FEATURES Crossgabled form, steep sloping roof, delicate cupola, and exposed framing elements at the gable ends give this small building a graceful air. The entry way is very sturdy ; it has heavy molding, pilasters, and paneled door which are, however, relieved by lacy scrollwork in an open pediment. | | |
