HISTORIC RESOURCES INVENTORY:
 Buildings & Structures

SURVEY OF GUILFORD, NEW HAVEN COUNTY, 06437
 June-December 1981

1. ADDRESS 575 Leete's Island Road
(map 19, lot 11)
2. NAME
(historic) Pelatiah Leete I
NAME
(common)
3. USE
(historic)
USE
(present) Private house
4. IF MOVED, WHEN AND FROM WHERE:

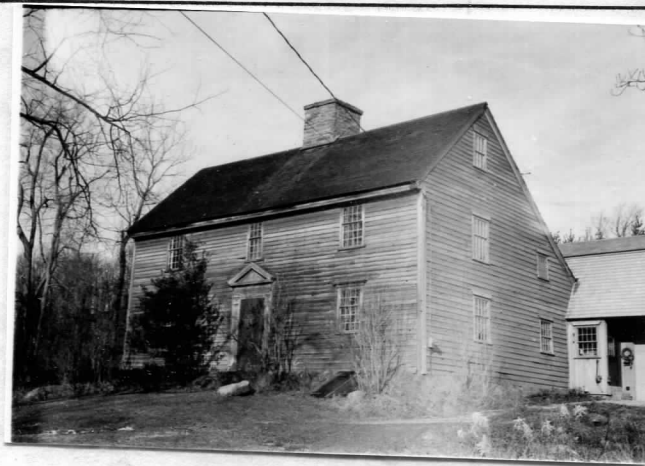
GLFD NEG 21:29

5. ARCHITECT
6. DATE c 1710 } See No. 9 below
c 1745 }
7. ALTERATIONS
Gambrel roof addition on right rear side.

8. NOTABLE FEATURES
8/12 sash except in the gable (6/6) and over the front door (6/9) - all windows were copied from an original window found in the attic; applied lintels on side; crown moulding over front windows; doorway.

Almost every detail of this house, exterior and interior, is significant because of careful preservation, documentation, and restoration. It is a fine example of the integral leanto house with a five-window facade. It has an 18th century pedimented doorway ornamented with a red rosette in the center of the pediment and in the capitals of the pilasters. Windows and clapboards are precise reproductions of materials found on the house. Thanks to careful restoration, this house gives an accurate sense of the original appearance of Guilford's 18th century houses. Its connection with the area's first settler as well as its architecture make this a singularly important house.
