HISTORIC RESOURCES INVENTORY:
Buildings & Structures

SURVEY OF GUILFORD, NEW HAVEN COUNTY, 06437
June-December 1981

1. ADDRESS 650 Leete's Island Road
(map 13, lot 19)
2. NAME
(historic) Calvin M. Leete, Sr.
NAME
(common)
3. USE
(historic)
USE
(present) Private house
4. IF MOVED, WHEN AND FROM WHERE:

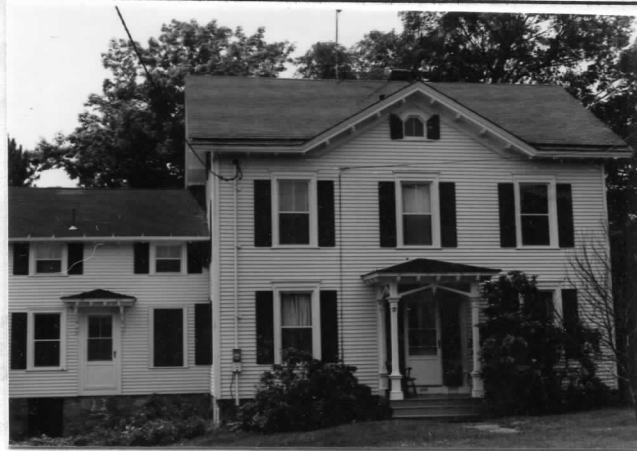
5. ARCHITECT 1874
6. DATE 1874
- BUILDER
STYLE Italianate
7. ALTERATIONS
Siding; steps missing to door on the side wing.
8. NOTABLE FEATURES Overhanging eaves; boxed cornice; elongated modillions; center gable; flattened-arch windows in the gables; bracketed door hood over side door; front porch with beveled posts, decorative pendants; double arched window in the front door; rear porch; bay window; large stone block foundation (under the main part of the house).

9. ARCHITECTURAL-HISTORICAL
The low gable on the facade of this house is punctuated by trim that gives the appearance of rafter ends, a motif that continues along its eaves and gables and is found again on the porches of this house. This is an expression of the taste of the 1870s and plays a supportive role complementing the older houses of the Leete's Island district.
