HISTORIC RESOURCES INVENTORY:
Buildings & Structures

SURVEY OF GUILFORD, NEW HAVEN COUNTY, 06437
June-December 1981

1. ADDRESS 968 Leete's Island Road
(map 18, lot 8)
2. NAME
(historic)
NAME
(common)
3. USE
(historic)
USE
(present) Private house
4. IF MOVED, WHEN AND FROM WHERE:

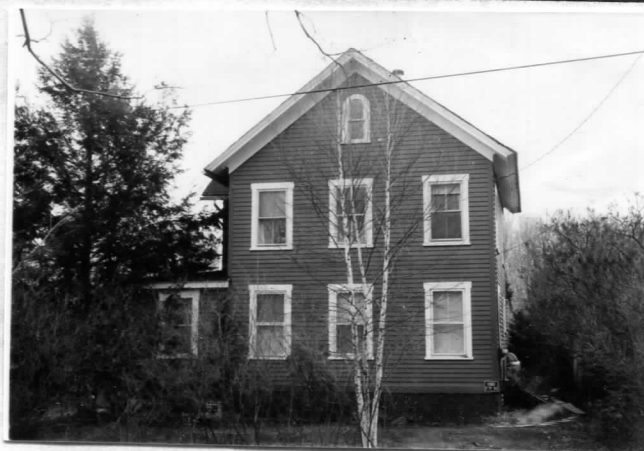
Negative 21:34

5. ARCHITECT
6. DATE c1850 BUILDER
STYLE Italianate
7. ALTERATIONS
Placement of the front door.
8. NOTABLE FEATURES
Wide overhanging eaves and raking; frieze; arched gable window;
brick foundation.
9. ARCHITECTURAL-HISTORICAL

An arched window in the gable is a major ornament of the simple facade of this house. The window placement may indicate that a door has been moved from the front to the side. A good example of the modest houses of this district. The house is one of a group of small houses.
